Service Bulletin

Bulletin No.: 23-NA-086

Subject: Information on Dark Spots Noticed in Headlamp Pattern When Vehicle is Pulled Up to a Wall or Garage

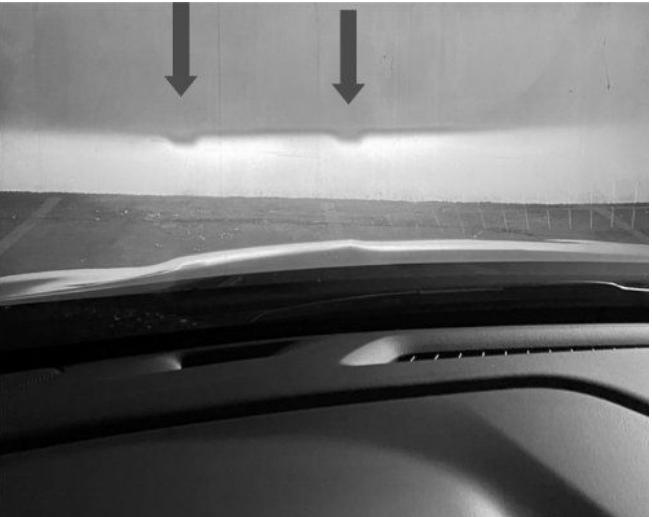
Involved Region or Country	North America, Bolivia, Chile, Colombia, Ecuador, Peru, Uzbekistan, Russia, Middle East, Israel, Palestine, Other Africa
Additional Options (RPOs)	Equipped with HEADLAMPS-LED (RPO T4L)
Condition	<p>Some customers may comment on dark spots in the headlamp pattern when the vehicle is pulled up to a wall or garage.</p>

<p>6340797</p> <p>Shown in the picture above is an example for Enclave, Blazer, Traverse, and Acadia headlamp.</p>

Cause	This dark spot in the lighting pattern is NORMAL and part of compliance with the IIHS safety standards to minimize glare to oncoming traffic.
Correction	DO NOT replace the headlamps for this condition. This is a normal function of the lamps.

Please communicate to the customer that the headlamp system is functioning as designed and this is a normal condition of their vehicle. Please share this information with the customer, including a copy of this bulletin.

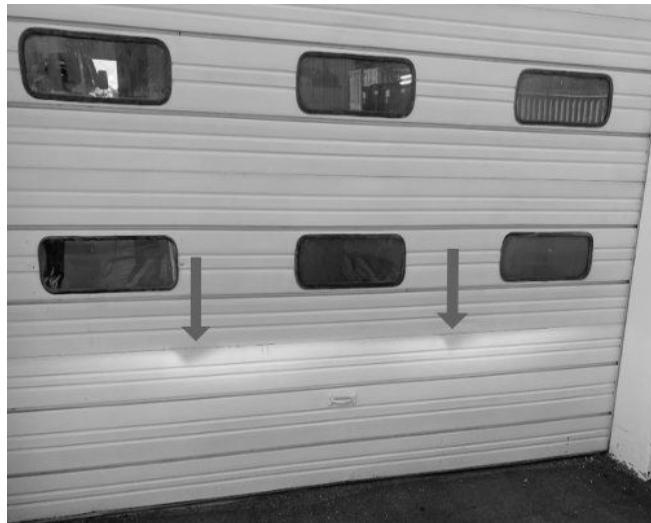
6472911

Shown in the picture above is an example for Encore, Encore GX, Envista, Trailblazer, and Trax headlamp.
