REFERENCE:	TSB: 17-002-25 REV. A GROUP: 17 - Rear Suspension	Date:	February 11, 2025	REVISION:	17-002-25
VEHICLES AFFECTED:	2025 (DT) RAM 1500 Pickup This bulletin applies to vehicles built on or after September 25, 2024 (MDH 0925XX) and on or before November 06, 2024 (MDH 1106XX) equipped with Standard Ride Height (Sales Code XZM) or Raised Ride Height (Sales Code XZN).	MARKET APPLICABILITY:			
		<input checked="" type="checkbox"/> NA <input type="checkbox"/> CH <input type="checkbox"/> EE <input type="checkbox"/> IAP <input type="checkbox"/> SA <input type="checkbox"/> MEA			
CUSTOMER SYMPTOM:	Customers may experience the following: <ul style="list-style-type: none"> An air leak from the rear air springs is causing the vehicle to lean to the left or right side, or lower at the rear. 				
CAUSE:	Rear air spring

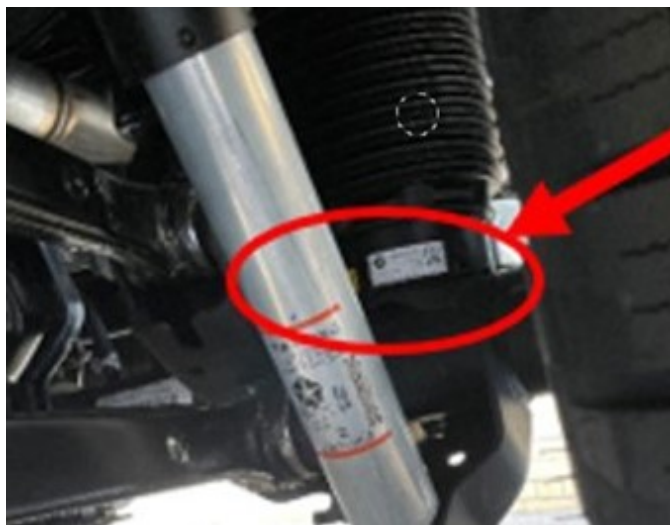
**Fig. 1**

1. Raise and support the vehicle. Refer to the detailed service procedures available in DealerCONNECT/ Service Library under: Service Info>04 - Vehicle Quick Reference / Hoisting / Standard Procedure.
2. Inspect the part numbers on both rear air springs [Fig. 1](#) to verify if either of the air springs fall on or between (24 276 and 24 296) [Fig. 2](#).

Rear Air Spring Label Location

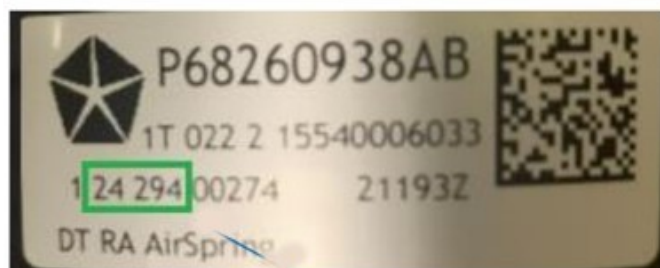
**Fig. 2**

Numbers On Label To Inspect

3. Do the part numbers on either of the rear air springs fall on or between **(24 276 and 24 296)** [Fig. 2](#)?
 - YES >>> Proceed to [Step 4](#).
 - NO >>> This bulletin does not apply. Use Inspection LOP (02-30-02-9B). Perform further diagnostics.
4. Replace the rear air springs as required. Refer to the detailed service procedures available in DealerCONNECT/ Service Library under: Service Info> 17 - Rear Suspension / Spring(s) / Removal and Installation.
