REFERENCE:	TSB: 23-008-25 GROUP: 23 - Body	Date:	February 14, 2025	REVISION:	23-004-24 REV. A
VEHICLES AFFECTED:	2019 - 2023 (KL) Jeep Cherokee 2021 - **2025** (WL) Jeep Grand Cherokee / Grand Cherokee L 2021 - **2025** (WK) Jeep Grand Cherokee 2022 - **2025** (WS) Wagoneer / Grand Wagoneer 2021 - **2025** (DT) RAM 1500 Pickup 2021 - **2025** (WD) Dodge Durango 2021 - **2025** (MP) Jeep Compass 2021 - **2025** (MV) Jeep Compass 2021 - **2025** (JT) Jeep Gladiator 2021 - **2025** (JL) Jeep Wrangler 2019 - **2025** (BV) Jeep Renegade			MARKET APPLICABILITY:	
				<input checked="" type="checkbox"/> NA	<input checked="" type="checkbox"/> MEA
				<input checked="" type="checkbox"/> SA	<input checked="" type="checkbox"/> IAP
				<input checked="" type="checkbox"/> EE	<input checked="" type="checkbox"/> CH
CUSTOMER SYMPTOM:	Some customers may report that on occasion, vehicle exterior head lamp assemblies are fogged with a light layer of condensation on the inside of the lenses.

CAUSE:	Headlamp condensation

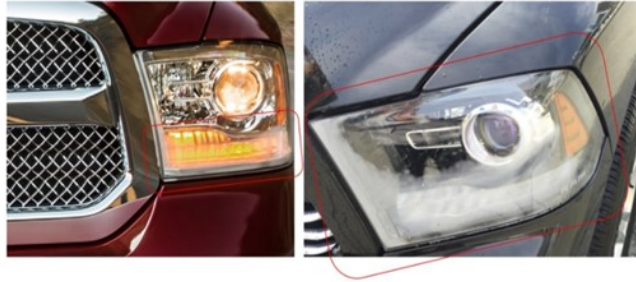
Customers may report that on occasion, vehicle exterior headlamp assemblies are fogged with a light layer of condensation on the inside of the lenses [Fig. 1](#).

This may be reported after the headlamps have been turned on and brought up to operating temperature, turned off and then rapidly cooled by cold water (such as rain, or the water from a vehicle wash). Headlamp lens fogging can also occur under certain atmospheric conditions after a vehicle has been parked outside overnight (i.e. a warm humid day followed by clear cool night).

**Fig. 1****Fogged Headlamp Examples**

A headlamp that exhibits condensation/fogging [Fig. 1](#) should be evaluated in a service bay environment according to the following steps:

1. Dry all water from the outside surface of the headlamp lens.
2. Operating all outside lamps for 20 minutes by:
 - Starting the vehicle engine.
 - Turning ON the vehicle headlamps and turn ON the hazard warning flashers.

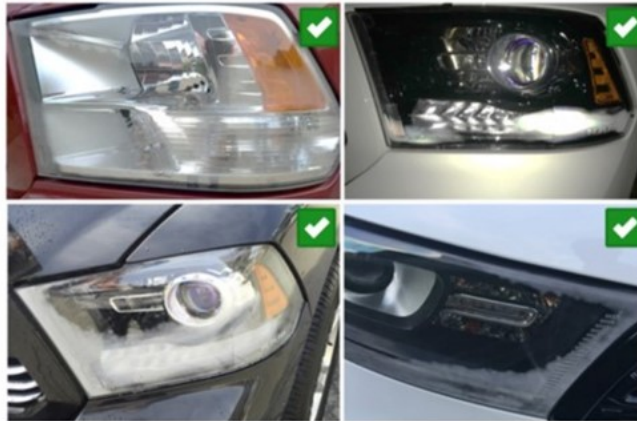
If the condensation/fogging has begun to clear [Fig. 2](#) from the headlamp lens after 20 minutes with the lamps operating, this indicates the lamp sealing has not been breached, and **the headlamp does NOT need to be replaced.**

**Fig. 2****Condensation/Fogging Beginning To Clear Examples**

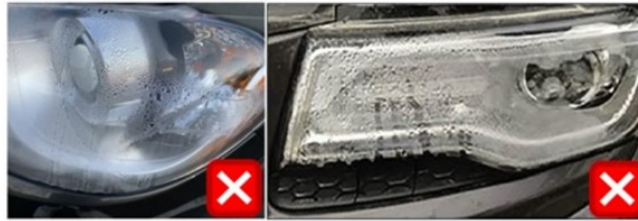
If the condensation/fogging has not begun to clear after 20 minutes with the headlamps operating, or the headlamp has large amounts of water droplets visible on most internal surfaces, this indicates a problem with the headlamp sealing that has allowed water to enter the headlamp. In this instance, the customer is also likely to report that moisture in the headlamp is always present and never disappears [Fig. 3](#).

Fig. 3
Condensation/Fogging Not Beginning To Clear Examples

NOTE: A headlamp that exhibits internal moisture permanently [Fig. 3](#) should be replaced.

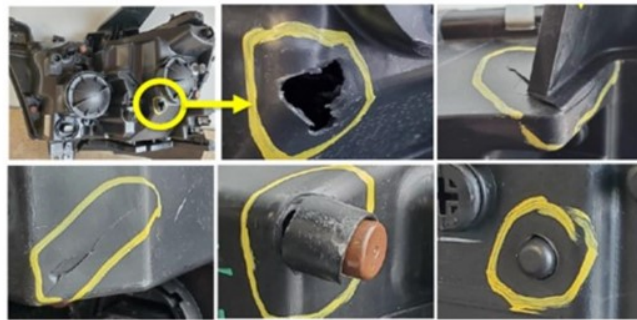
- **Damage:** Breakage on the headlamp housing will allow moisture/water to enter to the headlamp (damage, cracks, holes, etc.) [Fig. 4](#). If this is noticed, the Failure Code must be recorded accordingly: **11/BROKEN OR CRACKED**.

Fig. 4
Cracked, Damaged Or Broken Headlamp Examples

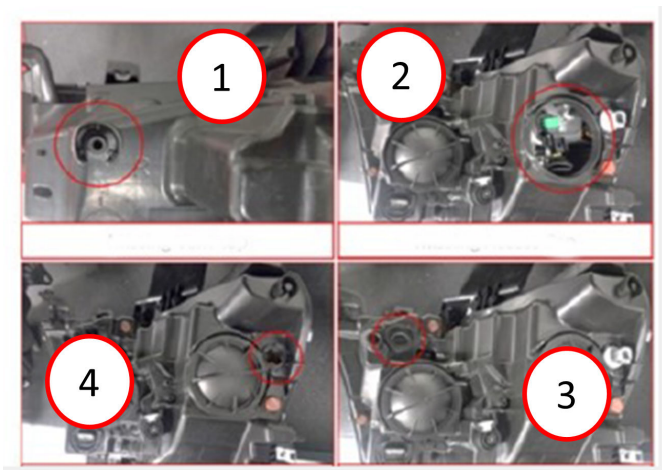
- **Missing Sealing Components:** Missing vent caps, access caps or bulb sockets will allow moisture/ water to enter to the head lamp [Fig. 5](#). If this is noticed, the Failure Code must be recorded accordingly: **1C / CONNECTOR LOOSE NOT ATTACHED**.

Fig. 5
Missing Sealing Components Examples

- 1 - Missing Vent Cap
- 2 - Missing Access Cap
- 3 - Missing Bulb Socket
- 4 - Missing Bulb Socket

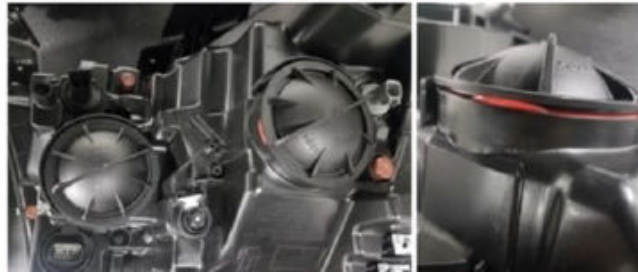
- **Sealing Components:** Missing/damaged vent caps, incorrectly installed access caps and bulb sockets, will allow moisture/water to enter to the head lamp [Fig. 6](#). If this is noticed, the Failure Code must be recorded accordingly: **1C / CONNECTOR LOOSE NOT ATTACHED**.

Fig. 6
Incorrectly Installed Access Caps Examples
