# Service Bulletin

Bulletin No.: 24-NA-032  
Date: February, 2025

**Subject:** Poor Fitting Charge Port Door and/or Charge Port Door Sticks Out at Bottom

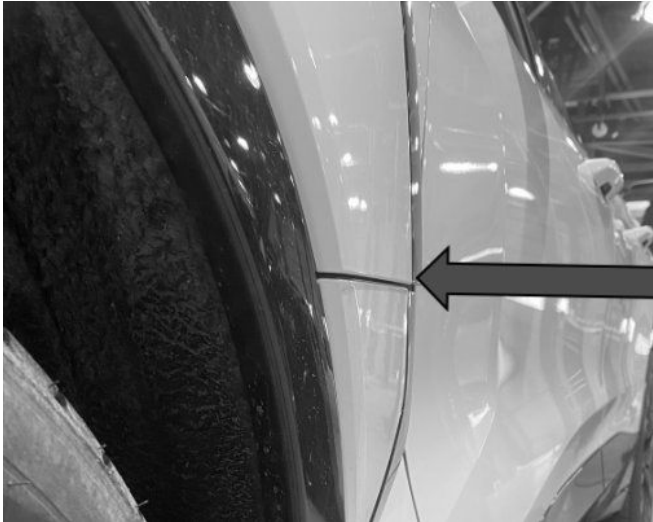
| Condition | <div></div> <div>Some customers may comment on the charge port door not closing all the way and/or the charge port door sticks out at the bottom. <span>6550658</span></div> |
| Cause | The cause of the condition may be due to excessive material on the charge port door. |

| Correction | Refer to the procedure below to remove some of the material so that the door may close fully as intended. |
