February 14, 2025

Electric Water Pump Relay Stuck Off in Freezing Temperatures - DTC P26CC (Electric Engine Coolant Pump Circuit Low Voltage)

Year	Model	Trim Level	VIN Range
2025	CIVIC HYBRID	ALL	ALL
2023-24	ACCORD HYBRID	ALL	ALL
2023-24	CR-V HYBRID	ALL	ALL

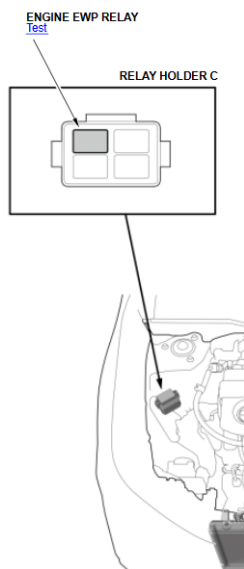
[Civic relay location](#)

Moisture intrusion in the Electric Water Pump (EWP) relay freezes during temperatures (at or below 32°F) causing the relay to malfunction.

1. Remove the engine EWP relay using the relay puller.

2. Install a new EWP relay into the fuse box.
NOTE: The new countermeasure EWP relay **will be** white in color.
3. Connect i-HDS to vehicle and clear all DTCs.
4. Start vehicle.
5. Perform ALL-DTC check with i-HDS to verify DTC P26CC is no longer stored.
