This Service Information Bulletin (Revision 8) replaces SI B11 07 23 **dated May 2024**.

E-Series	Model Description	Production Date
G05	X5 Sports Activity Vehicle	May 8, 2023 – June 17, 2023
G06	X6 Sports Activity Coupe	May 8, 2023 – June 17, 2023
G07	X7 Sports Activity Vehicle	May 9, 2023 – June 14, 2023
G70	7 Series Sedan	April 19, 2023 – June 20, 2023

The return springs on the exhaust camshaft followers (switchable rocker arm) may break.

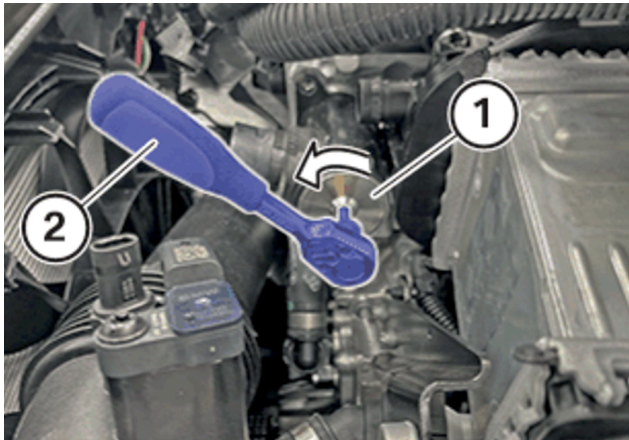
Cylinder 6 intermediate lever may interfere when trying to install the intake camshaft timing tools.

Place the variable valve timing (VVT) motor in minimum lift before installing the camshaft timing tools.

Use a 4 mm Allen socket (1) and a ratchet (2) to turn the VVT motor counter clockwise until it stops at the minimum lift end stop.

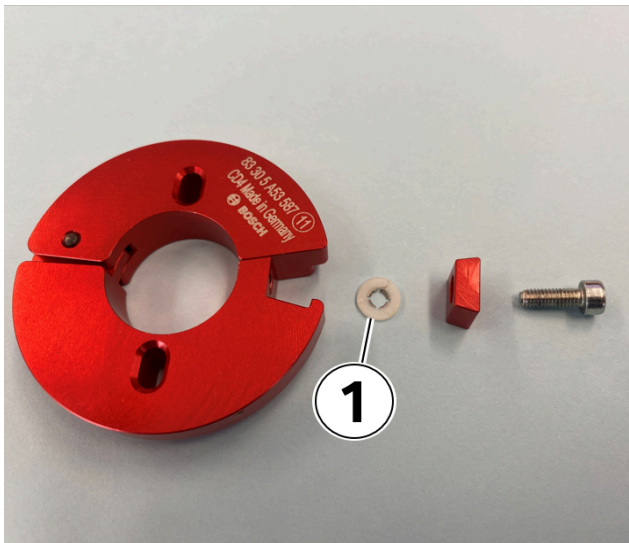
Tool 83 30 5 A53 587 may bind when removing it from both of the VANOS adjusters, the plastic washer (1) may be binding the tool and will not allow it to collapse when the screw is loosened.

Removing the washer entirely could result in the screw and wedge falling into the engine, the washer avoids loosening the screw too much.

Using a fine metal file, reduce the outside diameter of the plastic washer by approximately 1 mm to avoid this interference.
