SIB 11 11 24

2025-02-12

DELIVERY STOP: OIL PUMP SCREW CONNECTION

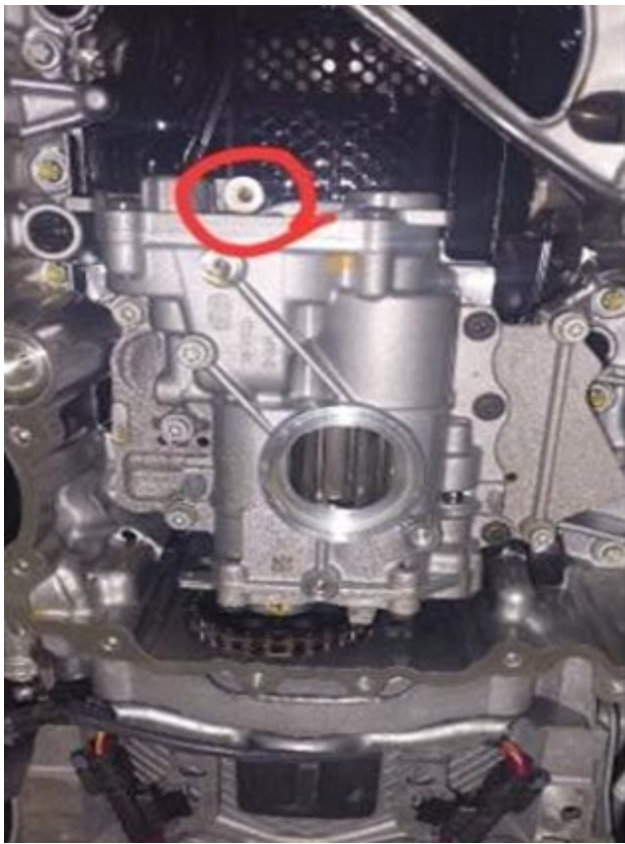
One of the six engine oil pump mounting screws may not have been tightened with the correct torque.

2. Tighten the screw on oil pump to 8.4 Nm. For the circle in the photo, the oil pump pickup has been removed for clarity.

If the screw is no longer present on the oil pump, it must be removed from the oil sump, and the threads on the screw and in the oil pump must be checked for damage.

If the thread on the screw and of the oil pump is not damaged, clean the screw, reinstall it into the oil pump and tighten the screw to 8.4 Nm.

If the thread of the screw or of the oil pump is damaged, replace the oil pump and its damaged screw. Refer to repair instructions 11 41 000 “Removing and installing/replacing the oil pump.”
