SIB 17 01 24

COOLANT LEAK AT CHANGEOVER VALVEThis Service Information Bulletin (Revision 2) replaces SI B17 01 24 **dated April 2024**.**What's New:**

COOLANT LEAK AT CHANGEOVER VALVE

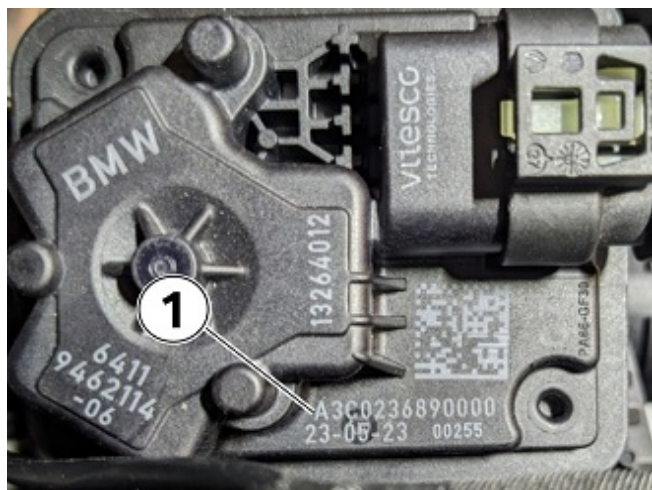
Check the production date of the remaining changeover valves (1). Improved valves were produced 5.1.2024 (January 5, 2024) and later.

Replace any* changeover valves PN 64 11 9 462 114) with a production date older than 5.1.2024 (January 5, 2024).
