U11 (X1 Sports Activity Vehicle)

U10 (X2 Sports Activity Vehicle)

The rear silencer is discolored.

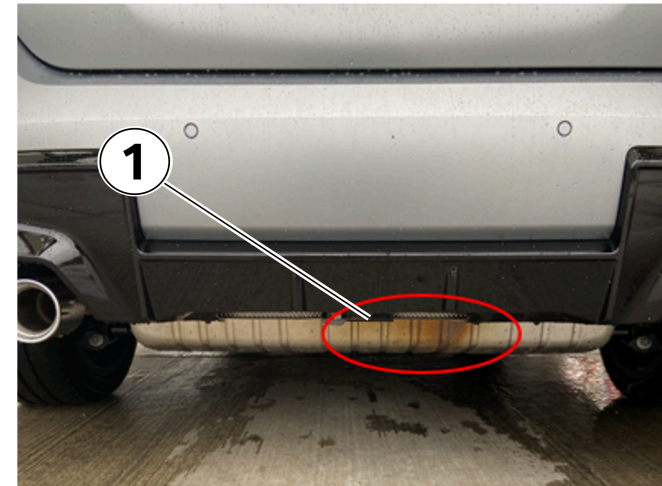
Tarnishing of the metal (1) on the rear silencer is caused by the heating and cooling of the exhaust.

Inform the customer this is a normal occurrence when the metal of the exhaust system gets to operating temperatures.

It does not affect the functionality, or the durability of the exhaust system.

This is not rust/corrosion.
