## Thor Motor Coach Technical Service Bulletin

| TSB # | <b>TSB 25-02</b> | | |
| Description/Title: | Taillight harness grounding | | |
| Affected Product Line(s): | Certain model year 2025 Pasadena & Inception | | |

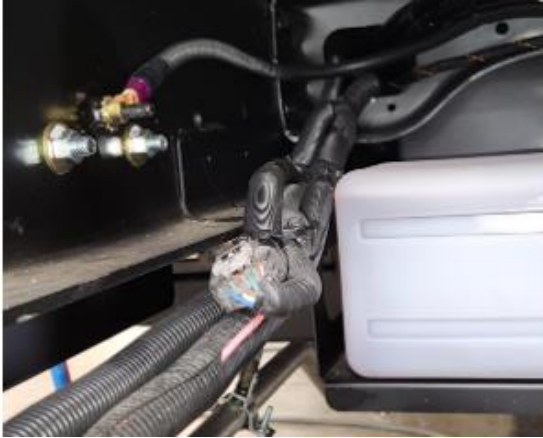
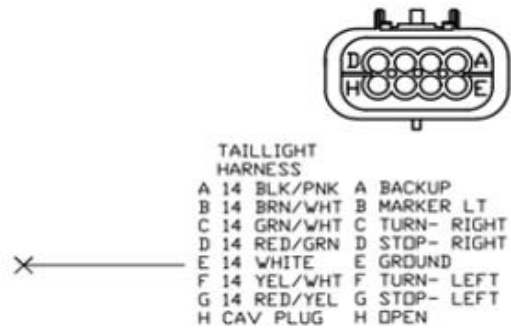
It has been found the camera display on the radio may glitch while the turn signal is activated and simultaneously using the brake.

1. Find the rear taillight harness connector located inside of the driver chassis rail.
2. Expose the taillight harness leading to the rear cap and cut the 14-gauge white wire near the chassis ground stud near the hydraulic pump assembly.

3. Cap off the chassis side of the white wire. It will no longer be needed.
4. Connect the rear cap side of the cut white wire to a heat shrink butt connector.
5. On the other end of the heat shrink butt connector, add a 14-gauge white wire to reach the chassis ground stud with a heat shrink eyelet.
6. Remove the chassis ground stud nut holding the hydraulic pump assembly ground and add the new taillight harness eyelet.
7. Reinstall the nut to the chassis ground stud.
8. Be sure to activate the heat shrink on the eyelet and butt connector.
