This Service Information Bulletin (Revision 2) replaces SI B51 10 22 **dated December 2023**.

Groaning noise in the front parcel shelf of the luggage compartment area. The noise is mostly head when the vehicle interior is cold.

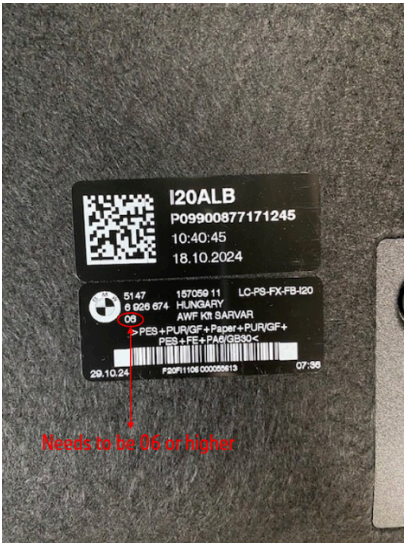
The AI (revision index) of the new part must be 06 or higher (circled).

Replace the front parcel shelf with part number 51 47 6 926 674, AI (revision index) 06 or higher.

1. Verify the customer’s complaint.
2. If the noise is reproducible with the front parcel shelf installed, then the shelf will need to be replaced with part number 51 47 6 926 674.
