This Service Information Bulletin (Revision 2) replaces SI B61 30 23 **dated December 2023**.

E-Series	Model Description	Production Date
G70	7 Series Sedan	November 10, 2022 – March 28, 2023

BMW AG has issued a Delivery Stop (effective November 21, 2023) on certain Model Year 2023 - 2024 BMW vehicles that were produced between November 10, 2022, and March 28, 2023.

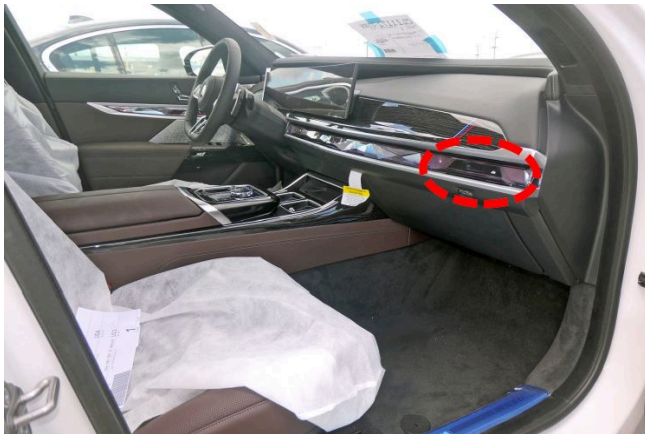
In the event of a voltage drop, comfort functions of the interaction bar may fail and not respond.

Software error in the BMW Interaction Bar.

This can lead to a failure of the air vent functions on the passenger side of the bar (circled).

Replace the BMW Interaction Bar **before vehicle delivery**.

Replace the BMW Interaction bar following repair instructions, **Removing, and installing the touch control box for the instrument panel** 61 31 147 | REP-REP-P-6131147-G70 - V.4.
