Technical Service Bulletin (TSB)
Telematics Box Module (TBM) Firmware Over The Air (FOTA) Software Updating from 4.37 to 4.38

REFERENCE:	TSB: 08-039-25 GROUP: 08 - Electrical	Date:	February 19, 2025	REVISION:	—
VEHICLES AFFECTED:	2021 - 2024 (RU) Chrysler Pacifica 2021 - 2024 (WD) Dodge Durango 2021 - 2024 (MP) Jeep Compass This bulletin applies to vehicles equipped with Global Telematics Box Module (Sales Code RDG).	MARKET APPLICABILITY:			
		<input checked="" type="checkbox"/> NA <input type="checkbox"/> MEA <input type="checkbox"/> SA <input type="checkbox"/> IAP <input type="checkbox"/> EE <input type="checkbox"/> CH			
CUSTOMER SYMPTOM:	Customers may not experience the following: <ul style="list-style-type: none"> Update URL's for ADA's whitelist – to collect data from ADAS customer. No customer impact. No customer symptoms. Other Software Enhancements included: <ul style="list-style-type: none"> Improves vehicle data communication with server for App data management performance. 				
CAUSE:	TBM Software

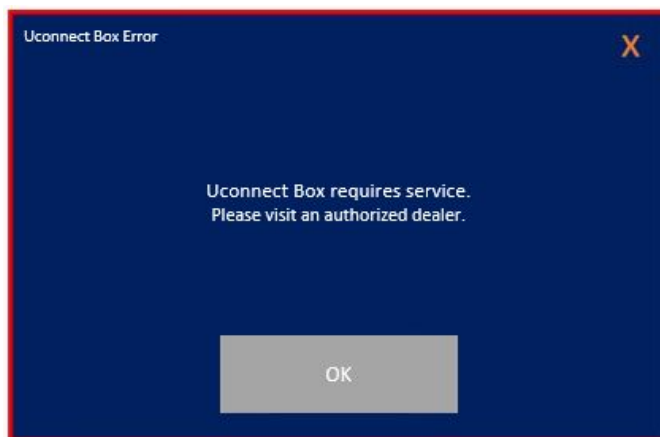
Fig. 1

Uconnect Box Error Message

Message display on the radio screen, “Uconnect Box requires service. Please visit an authorized dealer.” Fig. 1, with no active or stored Diagnostic Trouble Codes (DTCs) set by the TBM.

This bulletin provides information regarding the latest Firmware Over The Air (FOTA) update and provides the service technician an overview of the steps a customer will need to take to complete the update. The TBM software will be updated from 4.37 to 4.38.
