STAR ONLINE PUBLICATION

Case Number: S2223000074 Rev. A

Symptom/Vehicle Issue: Exterior Power Fold Mirror Does Not Travel To Full Extend or Fold Positions.

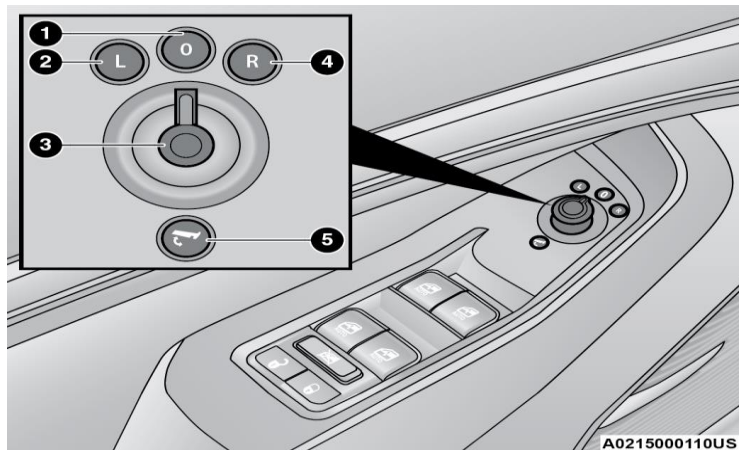
Power Mirror Switch

1 — Neutral Position
2 — Left Mirror
3 — Control Switch
4 — Right Mirror
5 — Power Folding Position

The door mounted exterior power folding mirrors have a clutch to allow manual folding. If the clutch is unlocked the mirror may not travel to the full extend and fold positions. To remedy a mirror that does not travel to full end positions, power fold the mirror to the fully folded position and continue to press the switch for 20-30 seconds until power fold mechanism locks into place. If that does not correct the issue, power unfold the mirror and continue pressing the switch for 20 - 30 seconds until the clutch locks.
