GENERAL MOTORS  
DCS7153  
URGENT - DISTRIBUTE IMMEDIATELY

Subject: N242471431 - Service Update  
Incorrect Brake Pad Calibration

Models: 2025 Buick Enclave  
2024-2025 Chevrolet Traverse  
2025 Chevrolet Equinox  
2024-2025 GMC Acadia  
2025 GMC Terrain

## N242471431 Incorrect Brake Pad Calibration

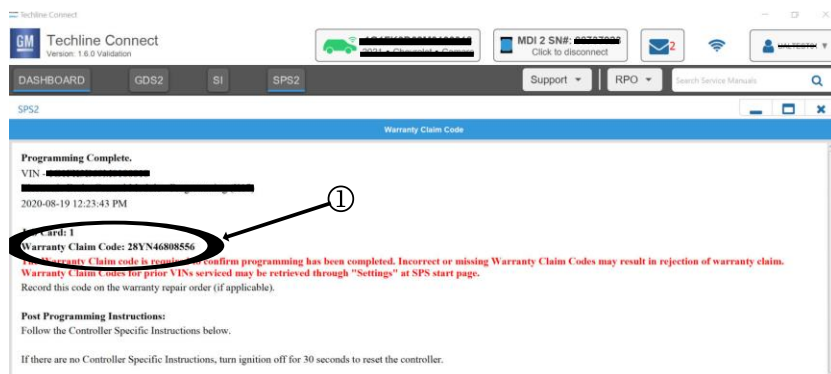
5644478

**Note:** The screenshot above is an example of module programming and may not be indicative of the specific module that is being programmed. Module selection and VIN information have been blacked out.

**Important:** To avoid warranty transaction rejections, you **MUST** record the warranty claim code provided on the Warranty Claim Code (WCC) screen shown above on the job card. Refer to callout 1 above for the location of the WCC on the screen.

1. Reprogram the K160 Brake System Control Module. Refer to *K160 Brake System Control Module: Programming and Setup* in SI.

2. Record SPS Warranty Claim Code on job card for warranty transaction submission.
