## STAR ONLINE PUBLICATION

**Case Number:** S2108000015 – Rev. J

**Symptom/Vehicle Issue:** Uconnect Box Require Service Message

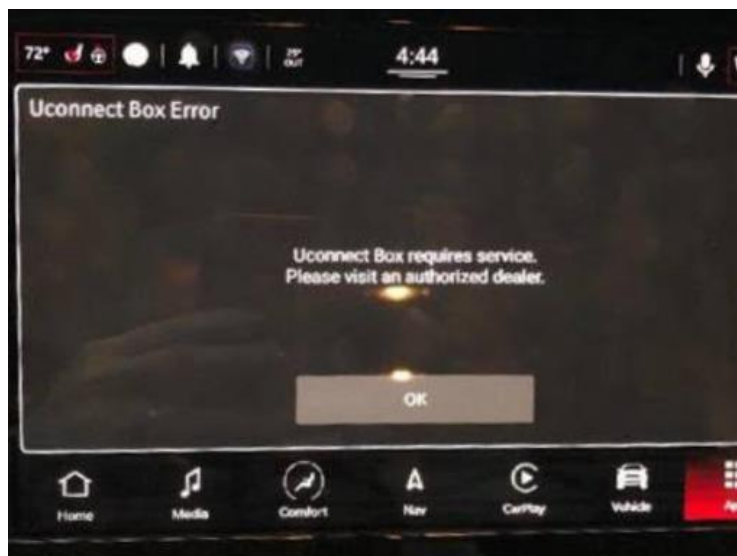
**Customer Complaint/Technician Observation:** Customer / technician may receive a message of “Uconnect box requires service. Please visit an authorized dealer” on the radio screen. It may happen right after the vehicle switching to customer mode or after a new Telematics Box Module (TBM) installed. The message may show up after every ignition on. The technician may not see any TBM or antenna open / short Diagnostic Trouble Code (DTC).

**Discussion:** To establish first time connectivity server connection, the TBM / radio needs to sync with vehicle manufacturing data and download a security certificate. Uconnect box requires service message will pop up if the certificate download failed.

1. Take a configuration report and scan report.
2. Verify if there is any active or stored DTC related to TBM or antenna.
3. Any active TBM DTC will trigger Uconnect box message. A stored DTC is possibly the cause of intermittent popup message failure. Please diagnose the issue per DTC repair procedures.

4. Perform ECU reset and clear the DTC if required.
5. The Uconnect popup message on a new vehicle / TBM without any active TBM DTC, might be due to missing the security certificate.

6. Move the vehicle to an area with good AT&T or Rogers network coverage and good GPS signals, so the TBM can establish server connection.
7. Please drive the vehicle for at least 5 km / 5 miles and leave the vehicle ignition on for 10 to 20 minutes.

8. Turn off the vehicle then turn it on. If the Uconnect box message pops up, try to do several ignition cycles.
9. If the message does not go away after 5 ignition cycles, create a STAR case and ask to check the status of VIN lock and factory feed in backend. (This only applies to new vehicle or new TBM replacement.)
