Subject: Transmission Fluid Leak Near Torque Converter Housing Area

This bulletin only applies to 8T65/45 or 9T45/50/60/65 transmissions.

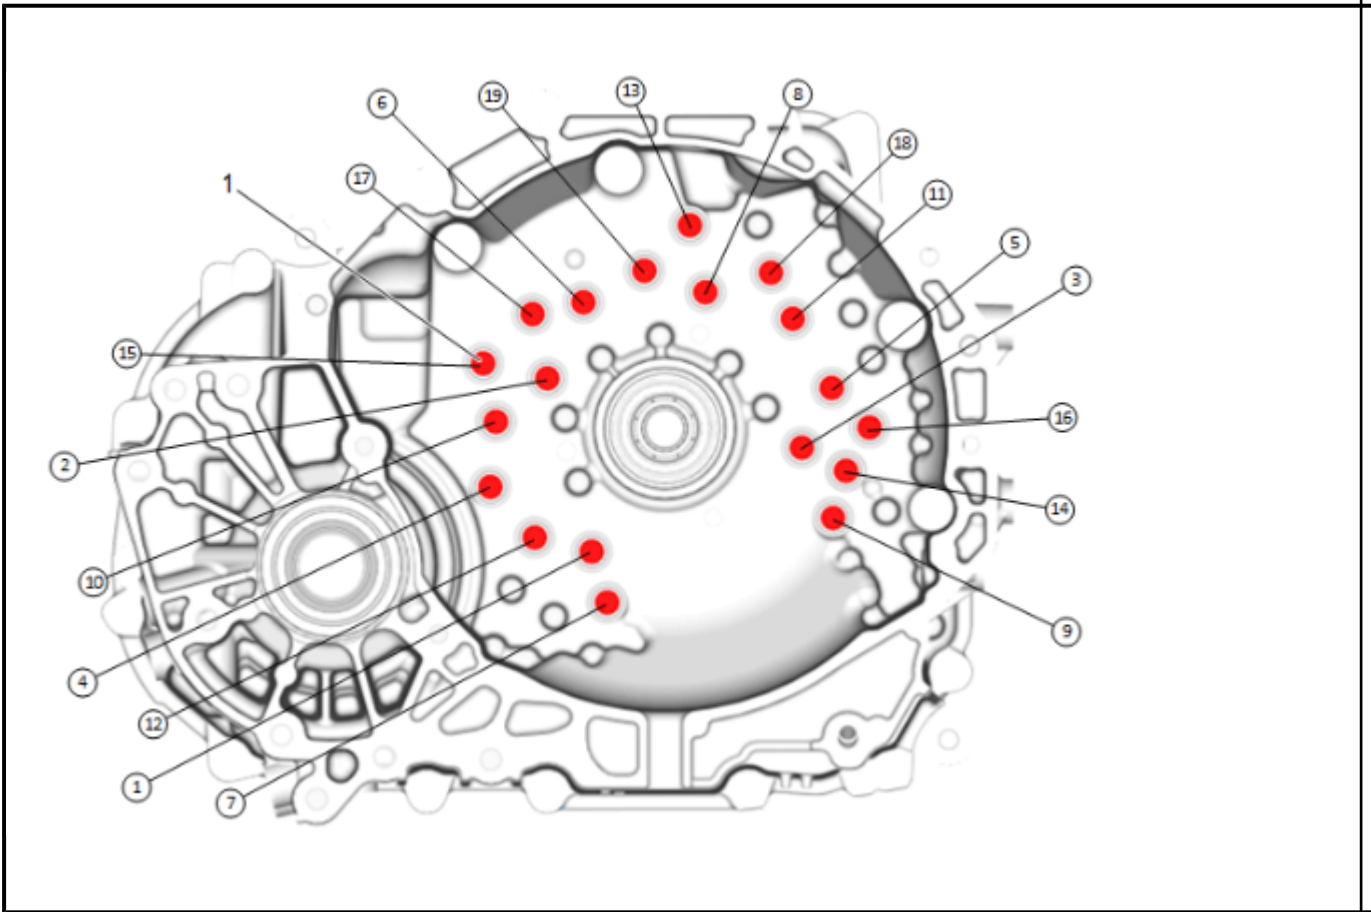
6419117

In-volved Re-gion or Coun-try	North America, Japan, South Korea, Europe, Palestine, Middle East
Con-di-tion	Some customers may comment on a transmission fluid leak. Some technicians may comment on a transmission fluid leak coming from the torque converter housing.

This condition may be caused by the transmission pump bolts were not fully torqued.

- If the transmission Julian date is between 24 160 and 24 311 and the vehicle comes in with a transmission leak in the torque converter housing area, order the bolt kit as required.

- Once the bolt kit arrives, remove the transmission, and verify that the bolts are loose.
- If loose, replace all the bolts and reinstall the transmission.
