Service Bulletin

Bulletin No.: 25-NA-030

Subject: Squeak Type Noise Heard When Applying the Brake Pedal

Brand:	Model:	Model Year:		Breakpoint:		Engine:	Transmission:
		from	to	from	to		
Chevrolet	Equinox	2025	2025	—	—	—	—
GMC	Terrain

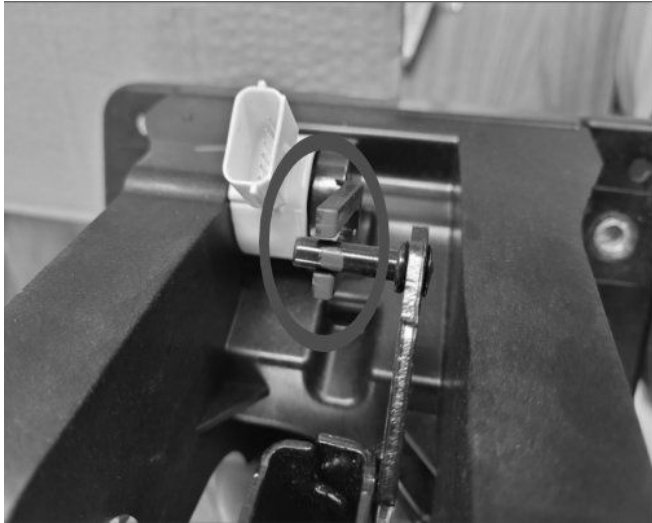
Involved Region or Country	North America, Middle East, Argentina (Mercosur), Brazil (Mercosur)
Condition	Some customers may comment on having a squeak type noise heard when applying the brake pedal.
Cause	The condition may be due to contact between the brake pedal position (BPP) sensor and the pin that moves it.
Correction	<div style="text-align: center;">

</div> <p>Reach up to the top of the brake pedal area and apply Multi-Purpose Lubricant, Superlube (GM Part No. 12346241, in Canada 10953474) or equivalent to the contact point, As shown in the picture above, and cycle the brake pedal a few times to distribute the lubricant.</p> <p style="text-align: right;">6836897</p>
