Service Bulletin

Bulletin No.: 22-NA-068

Subject: Diagnostic Tips for Park Assist Off Message / Unwanted or False Park Assist Alerts / No DTCs

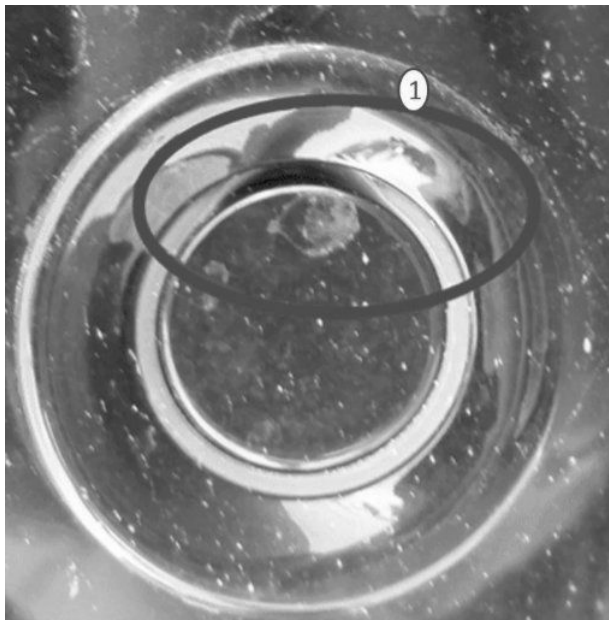
5794928

- Perform a visual inspection of the park assist sensor(s) and bezel(s). Look for any stone chips/dents, paint chips, damage, etc., as well as any issues with the silicone ring. See example (1) below of a silicone ring which is not properly installed. If any issues are found, then repair as necessary.

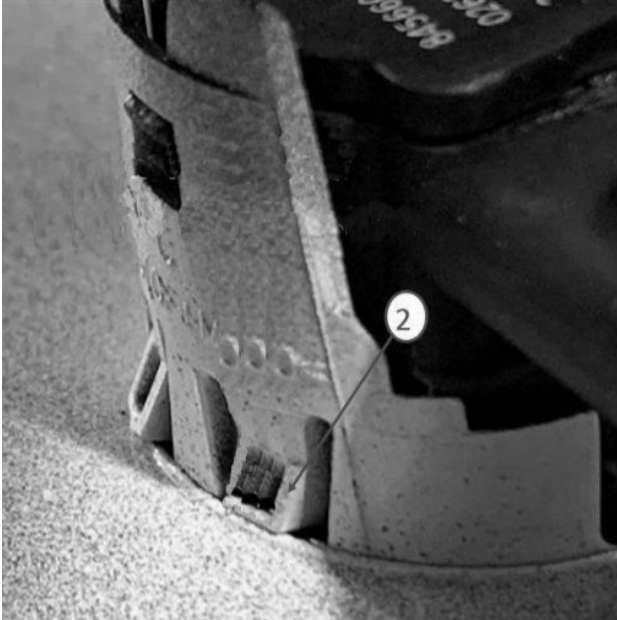
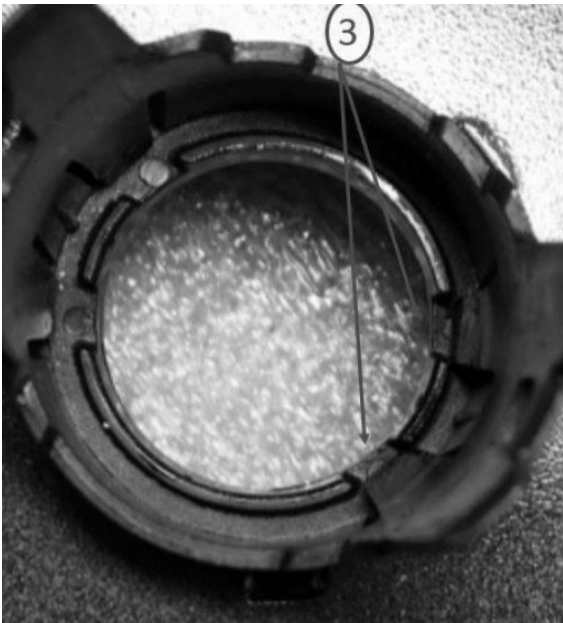
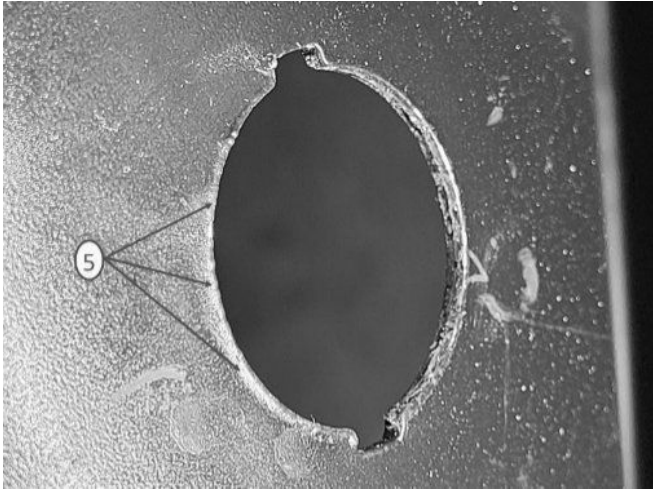
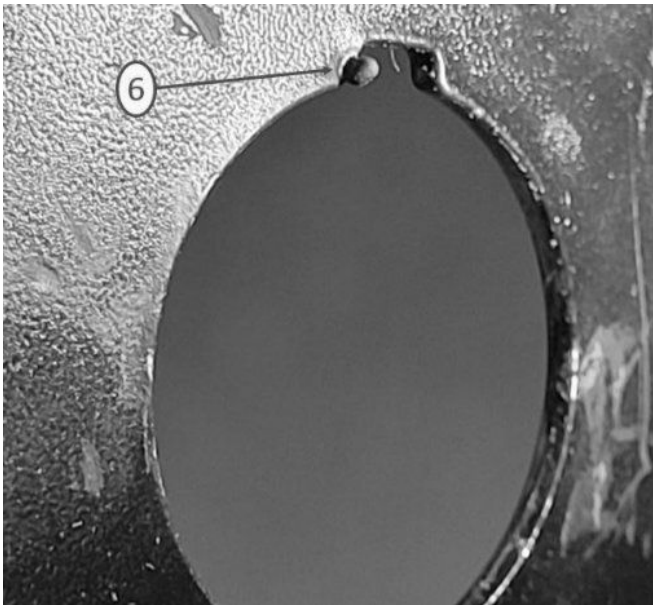
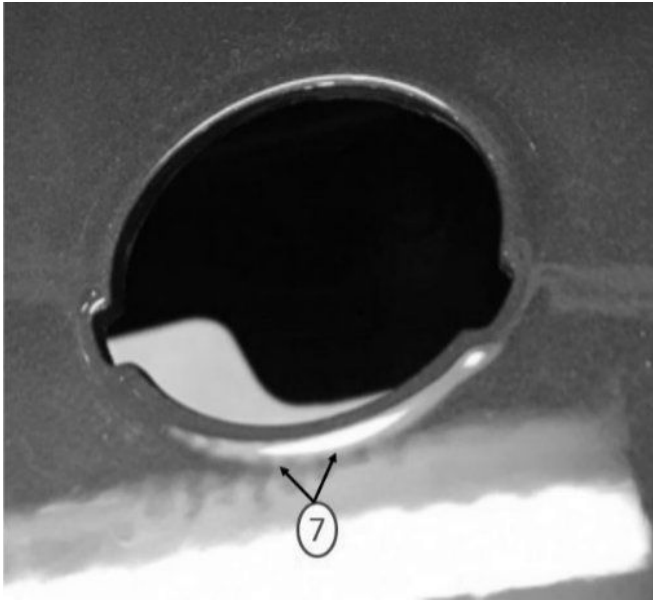
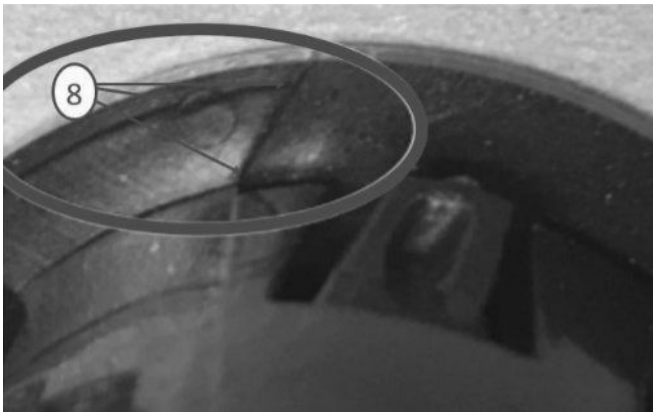
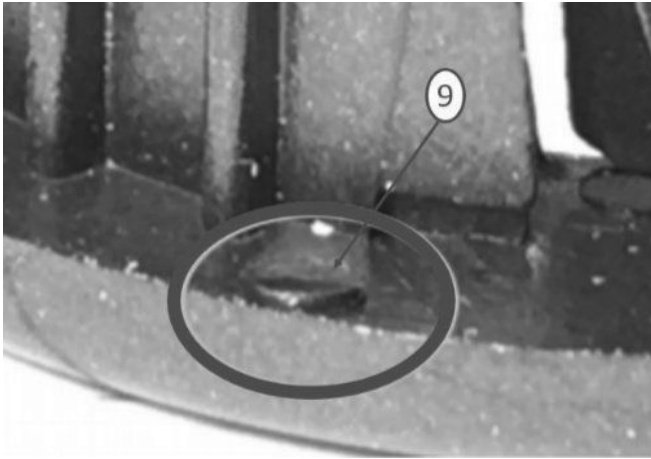
2. Inspect the park assist sensor bezel(s) for not being properly mounted in the bumper hole. If the bezel is not properly mounted into the bumper hole it can lead to a sensor grounding out or the sensor getting squeezed. The bezel has four locking tabs that secure the bezel to the bumper. Make sure all four mounting tabs are fully engaged. See example (2) for a mounting tab that is not fully engaged (view from the back side of the bumper/bezel). If any tab is not fully engaged, it can protrude into the opening where the park assist sensor mounts and cause it to ground out or get squeezed. See example (3) for a tab not fully engaged and protruding into the opening for the sensor. If any of the bezel mounting tabs are not fully engaging, inspect the following:

- Burrs on the back side of the bumper hole, see example 5 and 6
 - Excessive paint/clear coat on the bumper around the mounting hole, see example 7.
 - Plastic flashing on the park assist sensor bezel itself, see examples 8 and 9.

- Inspect the bumper hole for being slightly too small. The bezel should easily slide into the bumper hole without force.

If any of these concerns exist, then use a file or grinding wheel to remove any burrs or flashing. If needed, enlarge the bumper hole opening. On any exposed/bare metal apply an Anti-Corrosion Treatment, see Document ID: 2096919. After repairing any bumper hole or bezel issues then reinstall the bezel and make sure the four mounting tabs are fully engaged and then reinstall the park assist sensor. There is no need to replace the bezel or sensor unless they are damaged.

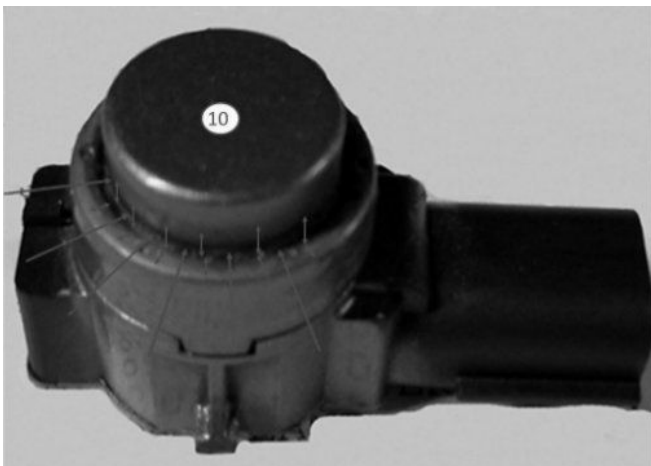
5794942

3. If the park assist sensors have been painted, it is important that only the tip of the sensor is painted and clear coated. The tip of the park assist sensor is isolated from the rest of the sensor body by an internal decoupling ring. If paint or clear coat is allowed to run or drip down the sides of the sensor's tip and/or into the gap between the body and sensor tip, as shown below, this can cause the sensor to ground out.
