# Service Bulletin

Bulletin No.: 23-NA-216

**Subject: Rattle Noise from Exhaust**

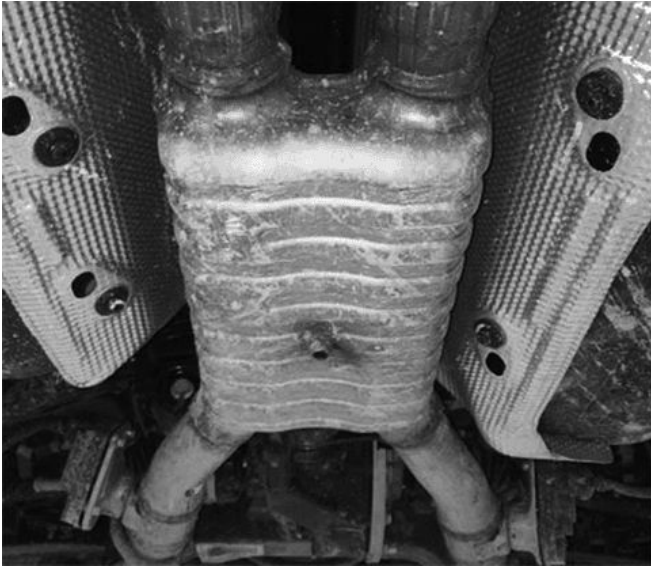
5124927

**Note:** Corrosion alone will not cause this concern. The quality of the actual welds is the issue. Dealership technicians are to inspect both the lower weld on the bottom of the resonator, as well as the upper weld on top of the resonator for signs of cracking.

- There is a tube located in the center of the resonator as shown in the graphic above. This is NOT a drain tube for condensation inside the exhaust system. This pipe is a structural component of the resonator that stiffens the upper and lower halves of the assembly. The welds holding this tube in place may crack, resulting in a rattle noise that can be heard by the owner of the vehicle. This will be most noticeable when starting the engine and/or applying the throttle.

<p><b>Correction</b></p>	<p>Inspect the lower weld on the bottom of the resonator, as well as the upper weld on top of the resonator for signs of cracking. If the concern listed above has been found, replace the rear portion of the exhaust system.</p>
--------------------------	------------------------------------------------------------------------------------------------------------------------------------------------------------------------------------------------------------------------------------
