Grecale Unwanted Alarm Activation

DATE: FEBRUARY 20, 2025

MODELS: M182 Grecale (All MY) equipped with OPT LSA (ALARM SYSTEM).

SECTION: 08.53 - 1 ALARM SYSTEM AND IMMOBILISER

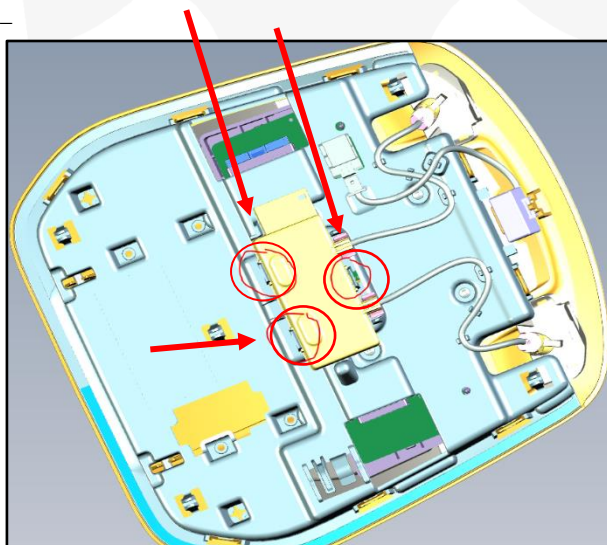
- Check that the ITM is fixed with the 3 clips marked in red in the following picture. Is the module fitted correctly? _____

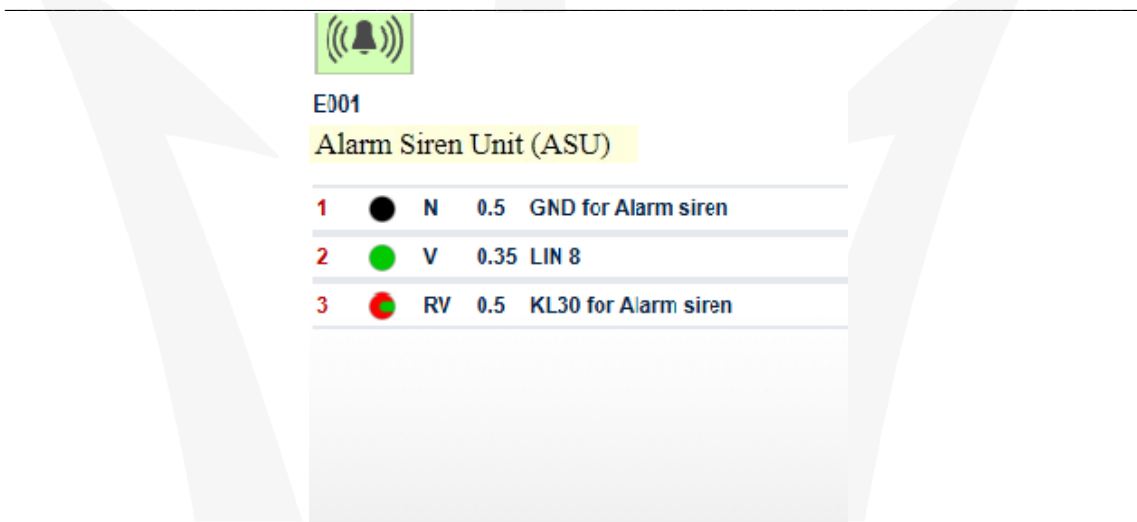
a. Check the ground (visual inspection), power supply (approx. 12 V), connectors, and wiring (connection integrity) of the siren (connector E001 on wiring diagram). Were any faults found? _____ If faults were found, please specify _____

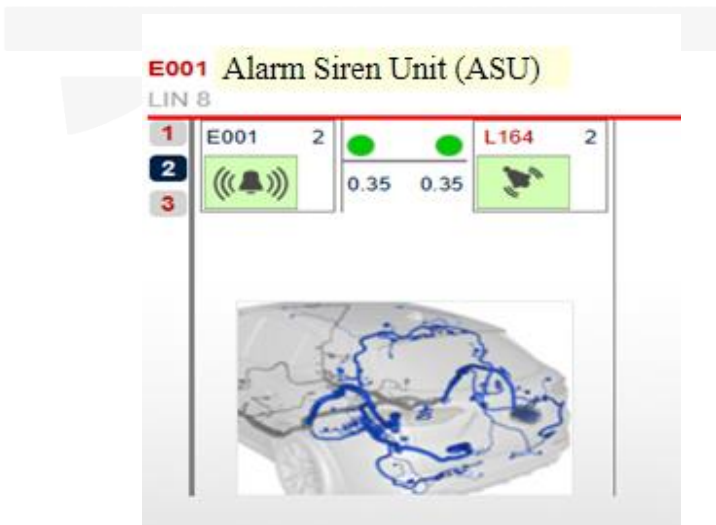
b. Check the continuity of LIN wiring between the siren and ITM. Is the continuity OK? _____ (record value in Ohm) _____
