Technical Information

Dashboard Leather Repair Procedure

MODELS: M157 Ghibli, M156 QP and M161 Levante (All MY).

CUSTOMER CONCERN: Dashboard leather bubbling or peeling

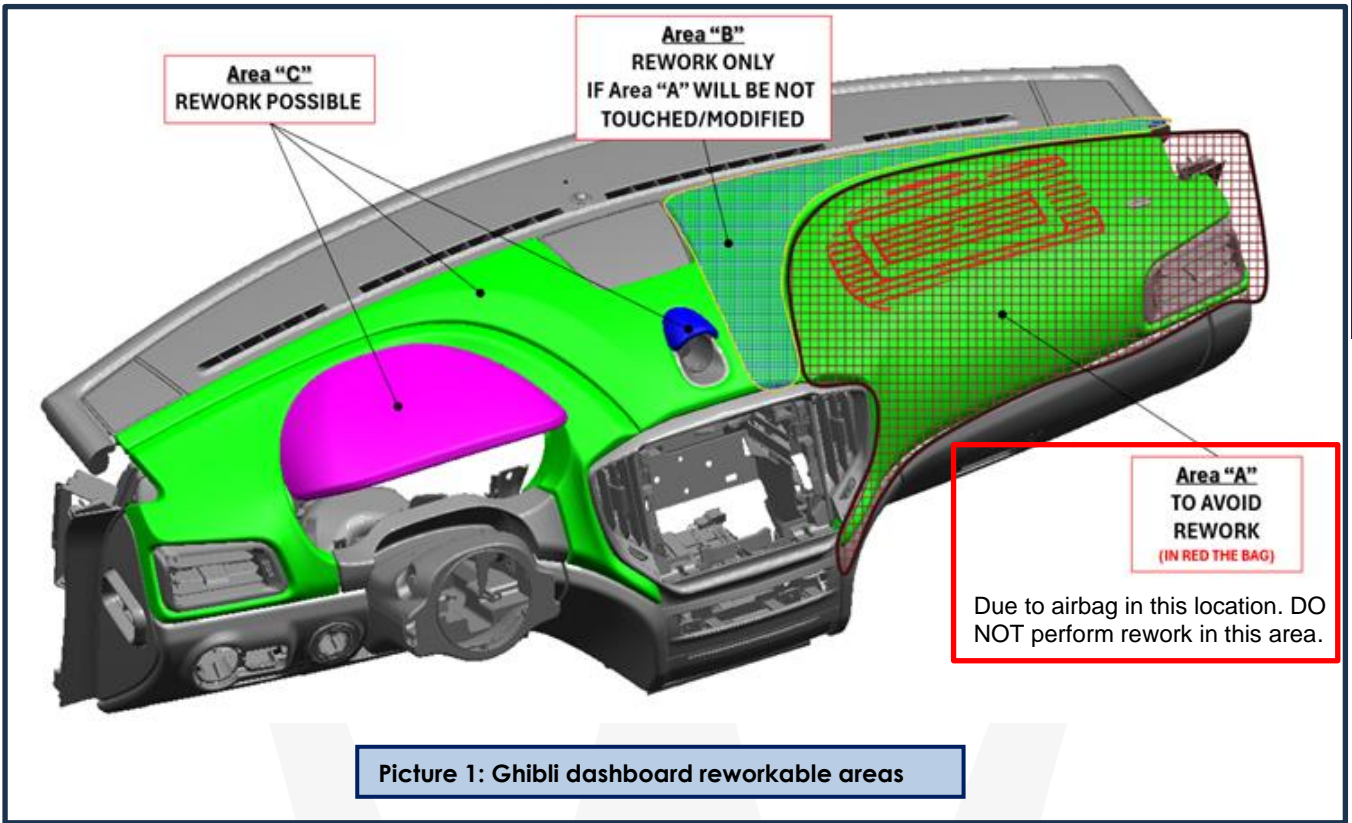
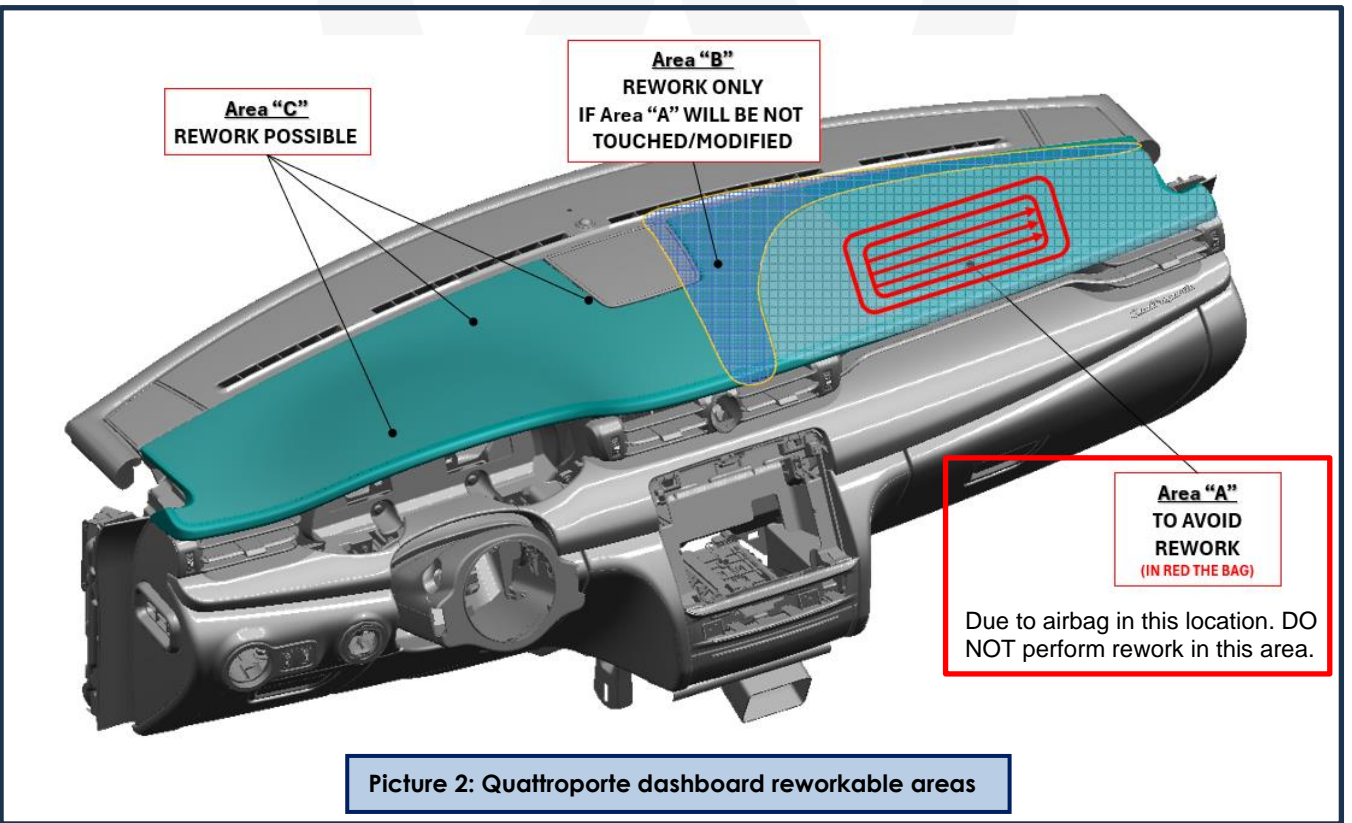
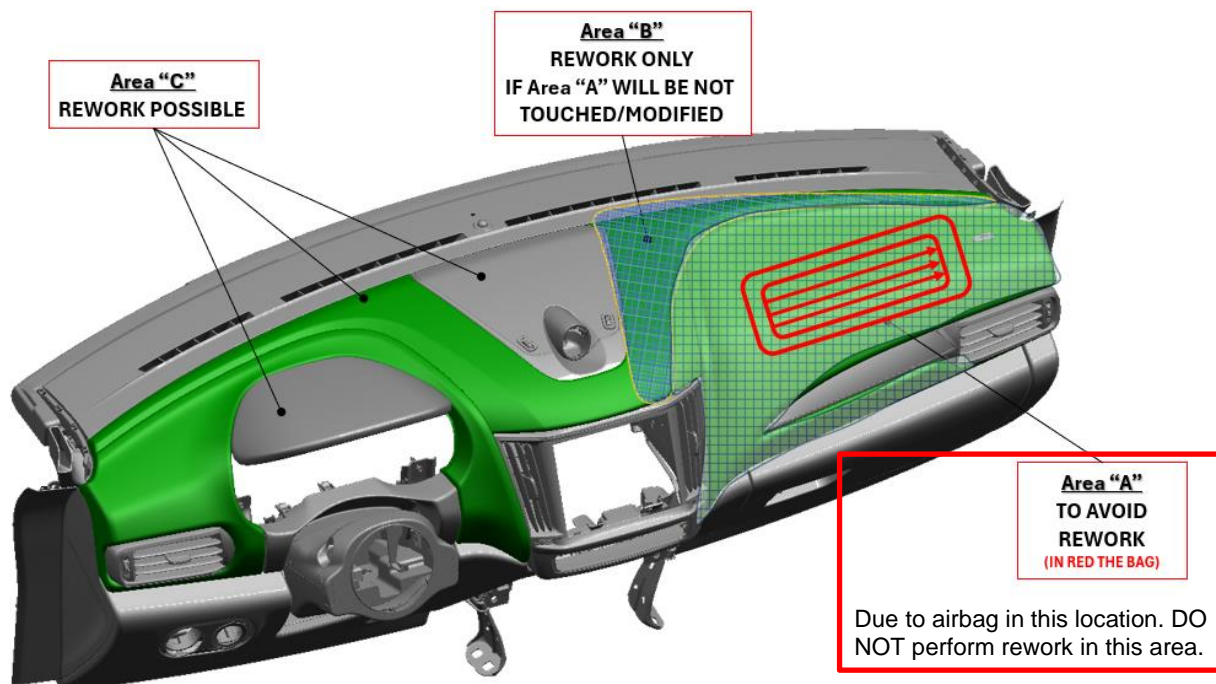
Picture 3: Levante dashboard reworkable areas

The repair below is applicable only to dashboard areas classified as "C" and "B". No rework or modification is allowed in the area classified as "A" due to the presence of the passenger airbag.
