**Location:** Hybrid / Electrical

**Topic:** McLaren Artura eMotor Overtemperature Diagnosis Guide

**Diagnostic Trouble Codes:** P0A2A29 P160068 P0A2A1C P0A2B98

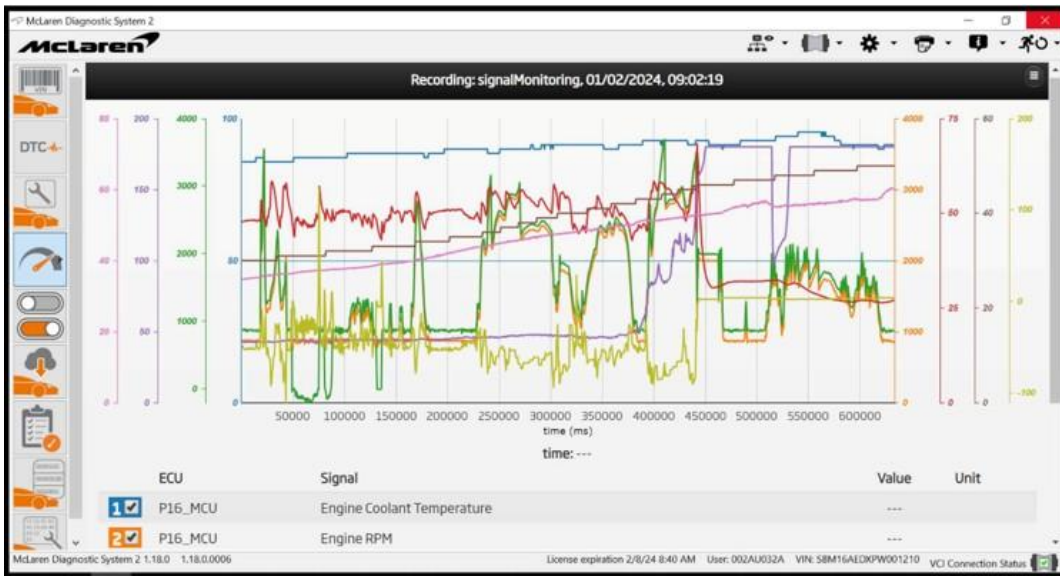
If the motor stator measured temperature (purple trace) jumps from circa 30 - 120°C to 180°C instantaneously, this indicates a break in the line (open circuit) somewhere between the MCU and the temperature sensor in the eMotor.

@45000ms temperature instantaneously rises, drops then rises again

If the temperature on the purple trace drops down to -40°C instantaneously this indicates a short circuit.  
 If any of the above symptoms are presented in the log, please submit your findings on the TR before advancing to step 3.

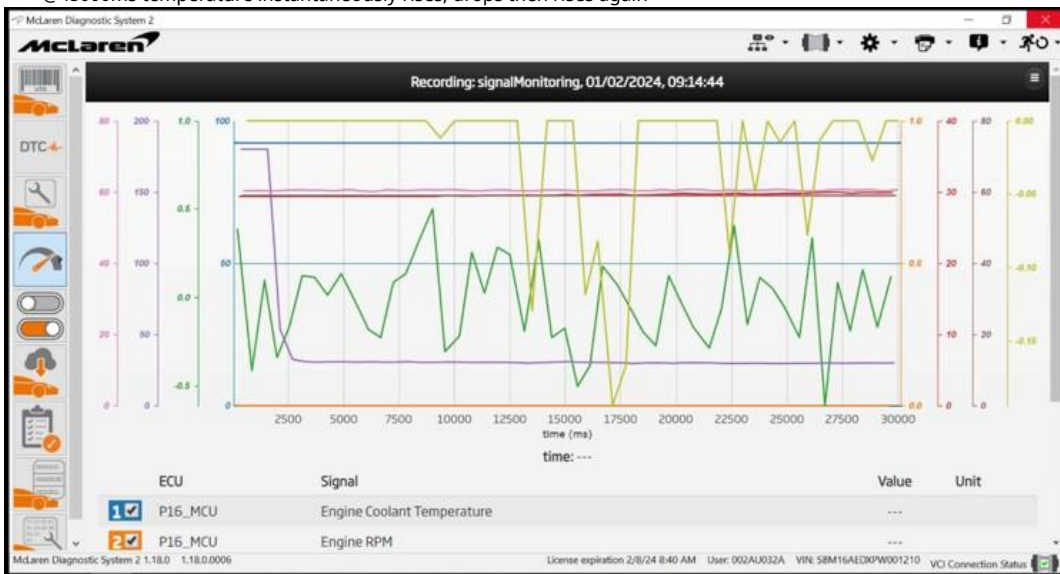
Diagram shows temperature at 180°C dropping to 40°C (Purple Trace)

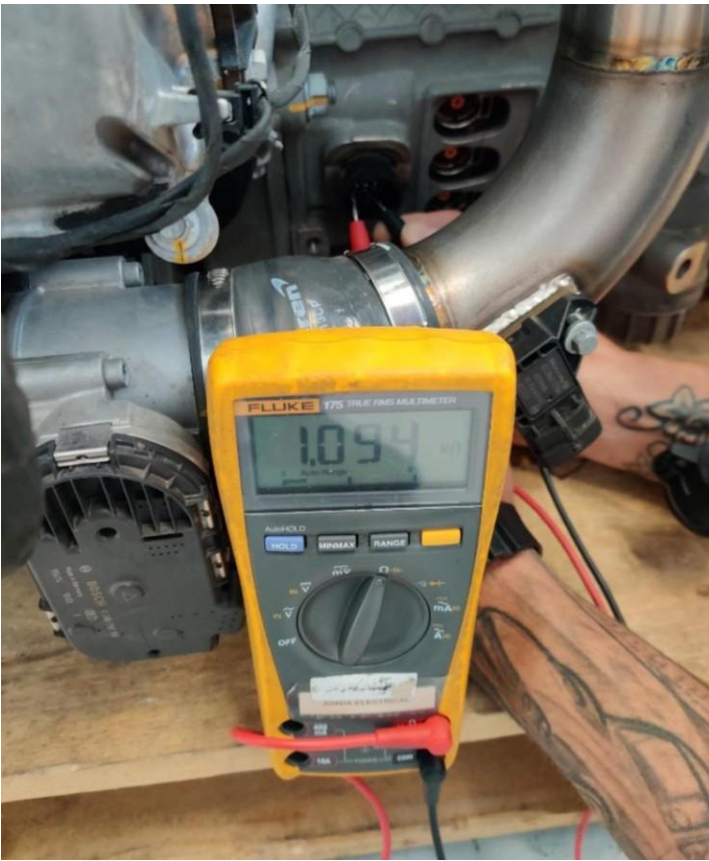
*Stator winding thermistor resistance at ambient temperature pins 12 & 13*

According to the specification, the resistance at ambient temperature should be between **1077.9 Ω** and **1155.4 Ω** as shown in the example below:

If the resistance value is not between the range specified above, please take a picture of the value and the measuring points on the connector, and attach your findings to the TR.

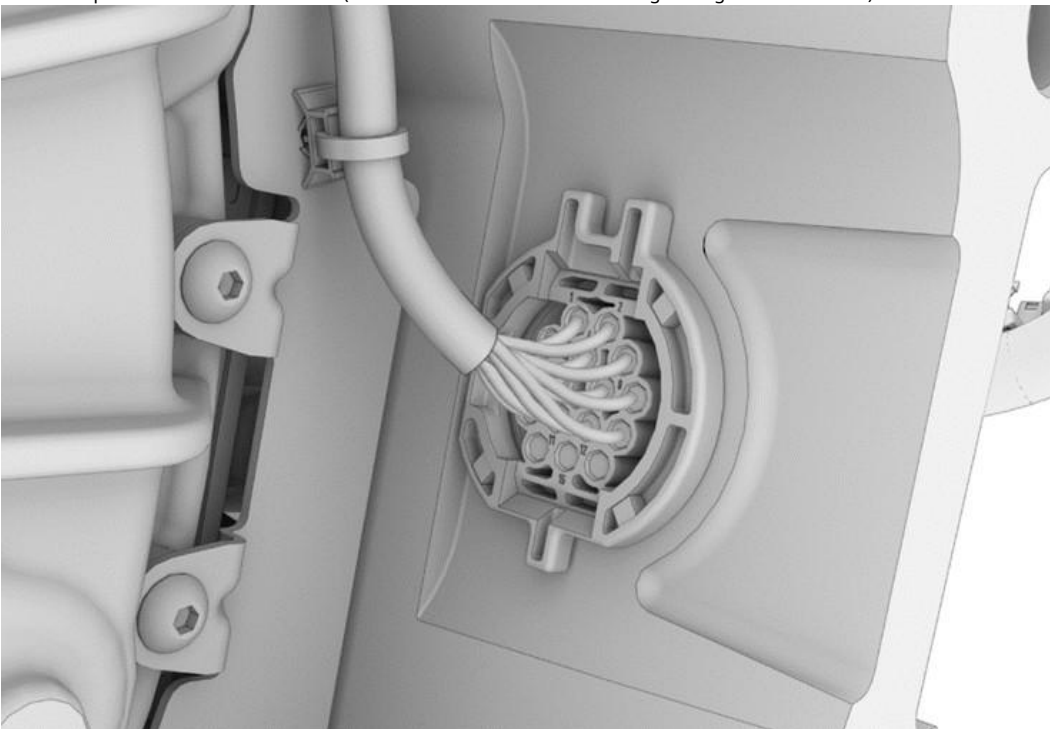
*Round connector inside transmission*

Please take a close look at this part of the connector and take a picture. In addition, spot if there is any presence of water traces or backed out pins.

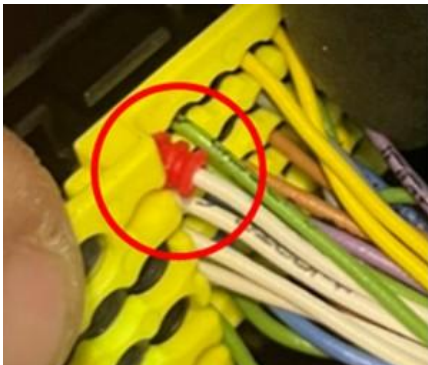
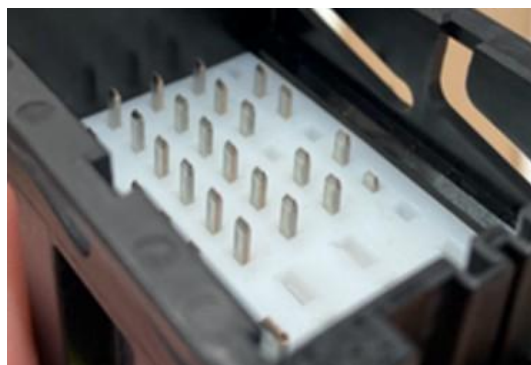
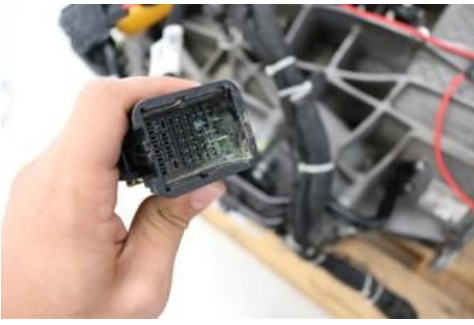
Check both (male & female) connectors for any signs of corrosion, water ingress or backed out pins as shown in the images below:

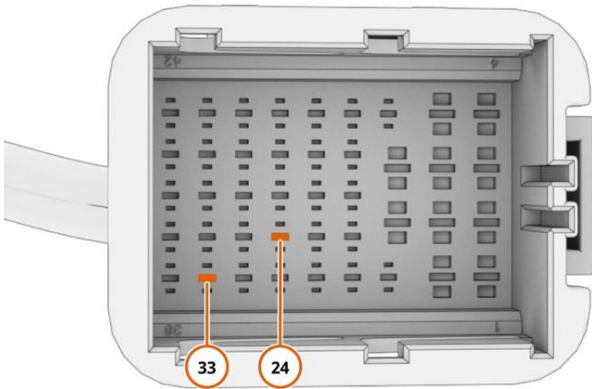
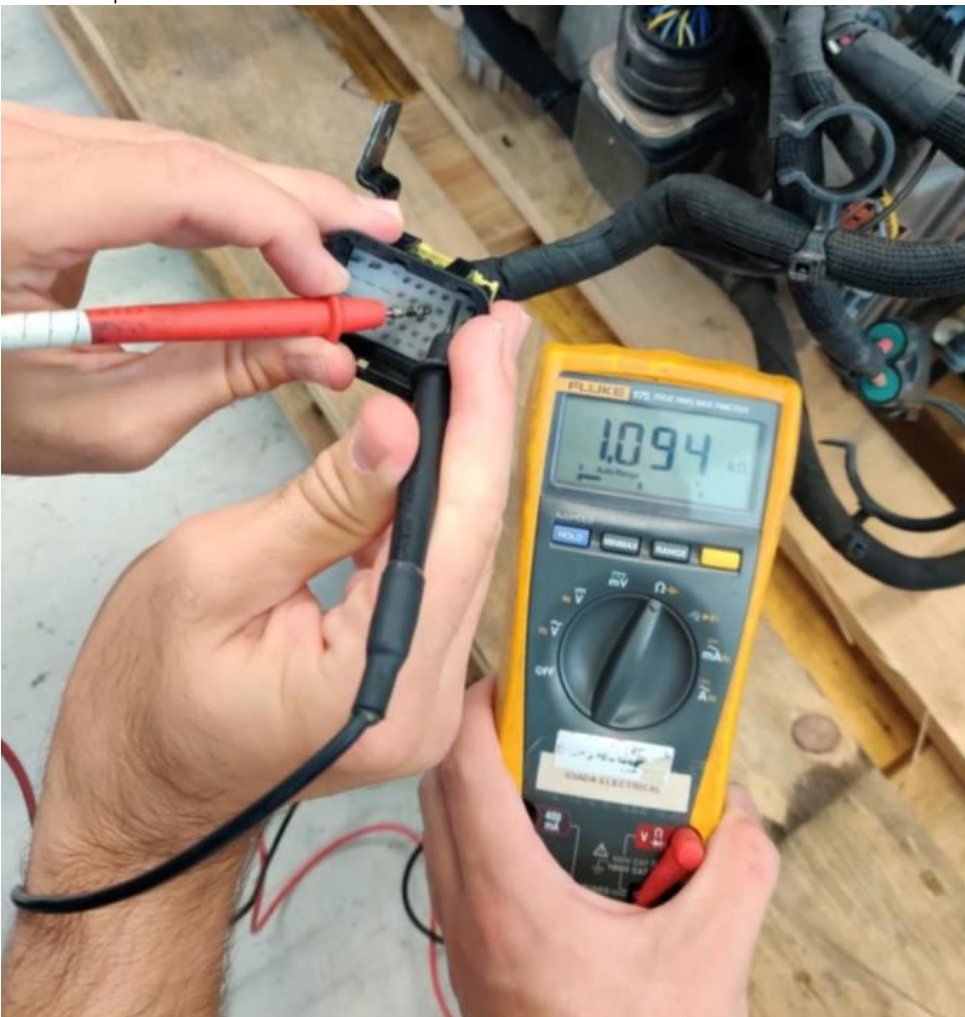
*Stator winding temperature thermistor checks at the transmission in-line connector pins 24 & 33*

As shown in the image below, the measured resistance should be similar to the one previously read and should be within the range of **1077.9  $\Omega$**  and **1155.4  $\Omega$**  at ambient temperature.

If the resistance value is outside of the specified range, please note the resistance value and take a picture similar to the above example and attach it to the TR. Wiggle the back of the connector and wires, to see if the resistance fluctuates.

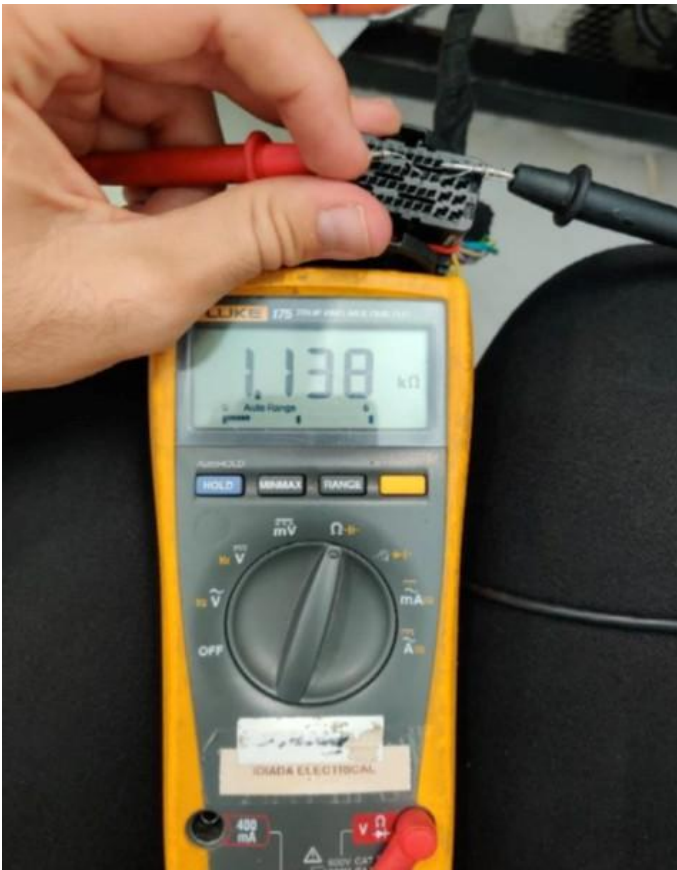
*Thermistor resistance check in the MCU connector*

The resistance reading should be similar to the one previously read and should be within the range of **1077.9 Ω** and **1155.4 Ω** at ambient temperature. Wiggle the back of the connector and wires, to see if the resistance fluctuates. If the resistance seen is outside of the specified range, please take a picture of the reading and set up and attach to the TR.
