SIB 41 01 25

SERVICE ACTION: LEFT REAR SIDE PANEL WATER CHANNEL INSPECTION

E-Series	Model Description	Production Date
F74	2 Series Gran Coupe	January 9, 2025 – January 15, 2024

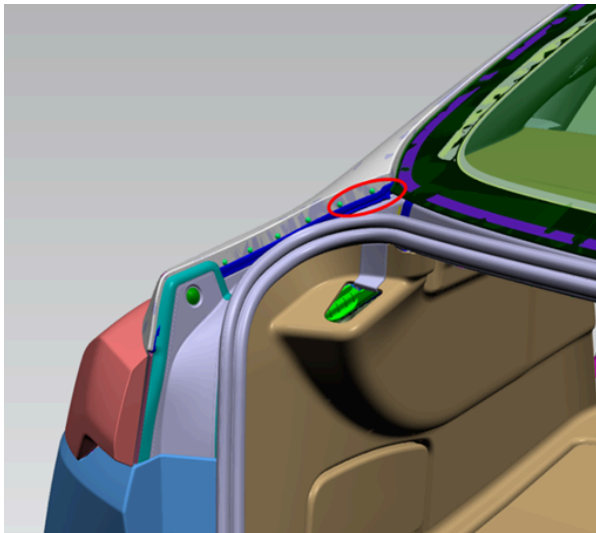
A crack may have formed in the upper left corner of the trunk opening (circled in red), where the quarter panel contacts the left lower corner of the rear window and trunk water channel.

Illustration of the inward-facing metal shows the general location of the possible crack, though the area to be checked in the Procedure is on the “back side”/outward-facing surface.

The PVC seam sealant applied to the water channel may not sufficiently seal the channel in the presence of the crack, resulting in a small water leak into the trunks interior.

1. Check the inner surface of the trunk metal/water channel for the presence of a crack or metal tear.

2. If a crack/tear is observed, pour water into the water channel and observe if water passes through the crack/tear.
3. If water is observed passing through the crack/tear, rework the trunk corner and weld the crack/tear, then perform localized painting.

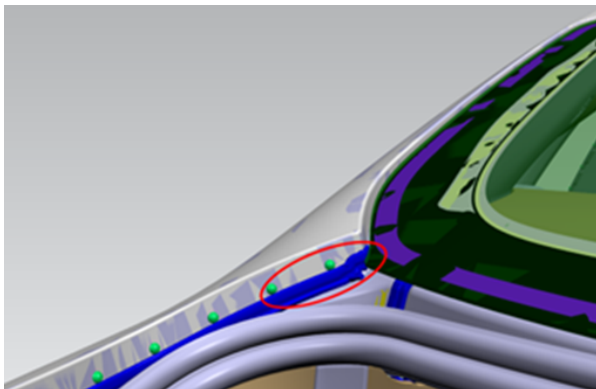
The green dots represent the location of spot welds.

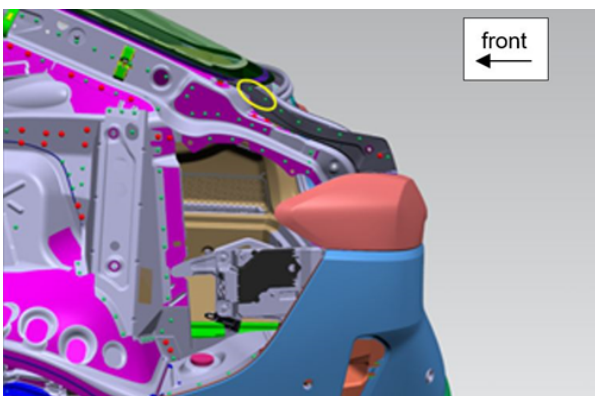
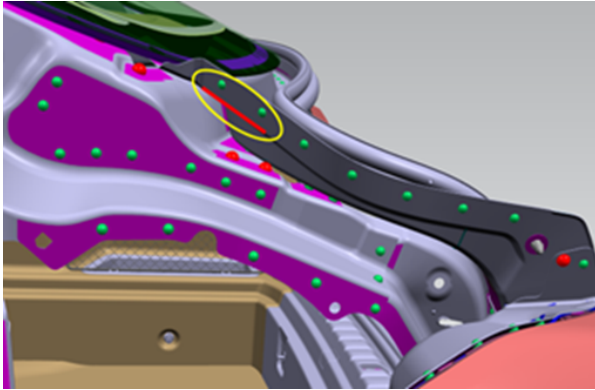
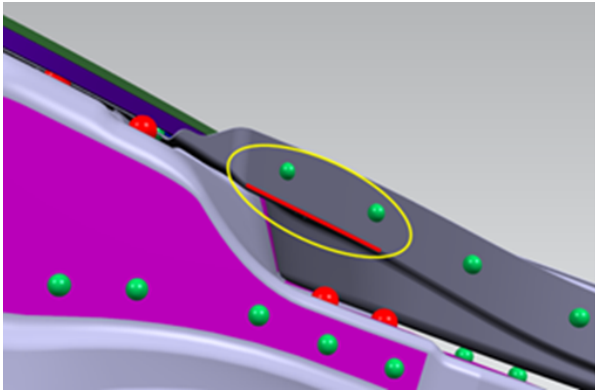
3. Using the borescope camera, inspect the area shown in the photo for a crack/tear where the panel curves/bends (see photos).

**Note: Red line demonstrates where the possible crack/tear would be located, on the “outboard facing” surface of the metal.**

- If **NO** crack/tear is seen/found on the panel, the vehicle can be reassembled, and the campaign can be closed
- If **A** crack/tear is seen/found on the panel, continue to step 4
