This Service Information Bulletin (Revision 1) replaces SI B51 31 24 **dated January 2025**.

| E-Series | Model Description |
|---|---|
| G30 | 5 Series Sedan |

With the M Performance aerodynamics accessory parts option installed.

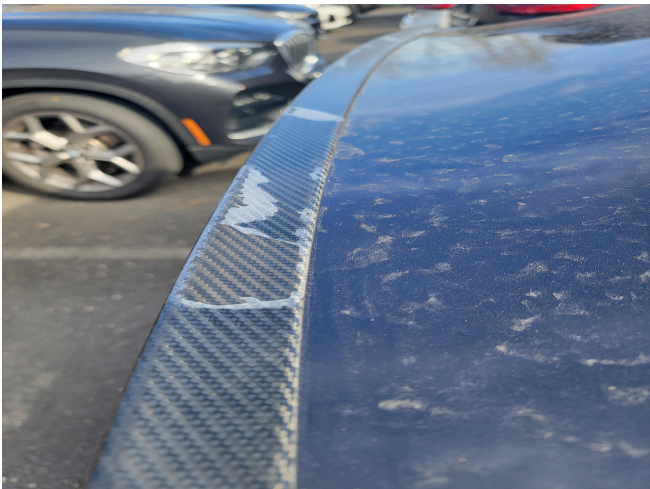
The clear coat on the carbon fiber M Performance rear spoiler is delaminating.

The clear coat did not adhere/bond to the spoiler correctly in the manufacturing process.

Replace the rear spoiler.
