SIB 64 02 25

## VIBRATION NOISE HEARD WITHIN INSTRUMENT PANEL

E-Series	Model Description	Affected Option Code
G26	i4 eDrive35, i4 eDrive40 Gran Coupe	With HA0 powertrain

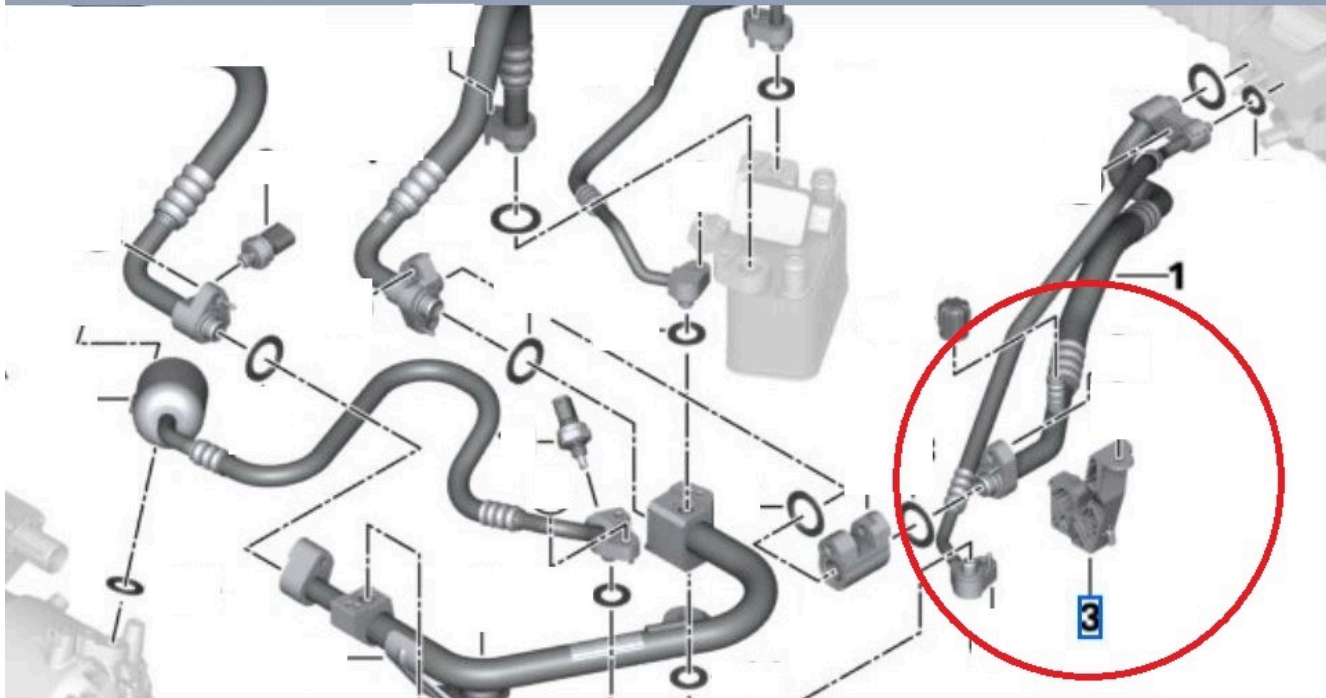
Diagram - 64\_2792: Coolant lines - Graphic

Movement between the Air Conditioning Refrigerant line (dual line part number (P/N) 64 50 9 474 791, #1 in picture) and bracket (suction pipe air conditioner P/N 64 50 9 874 025, #3 in picture).
