E-Series	Model Description	Production Date
U11	X1 Sports Activity Vehicle	Vehicles produced up to May 10, 2024

The customer states that the air bag warning lamp is illuminated.

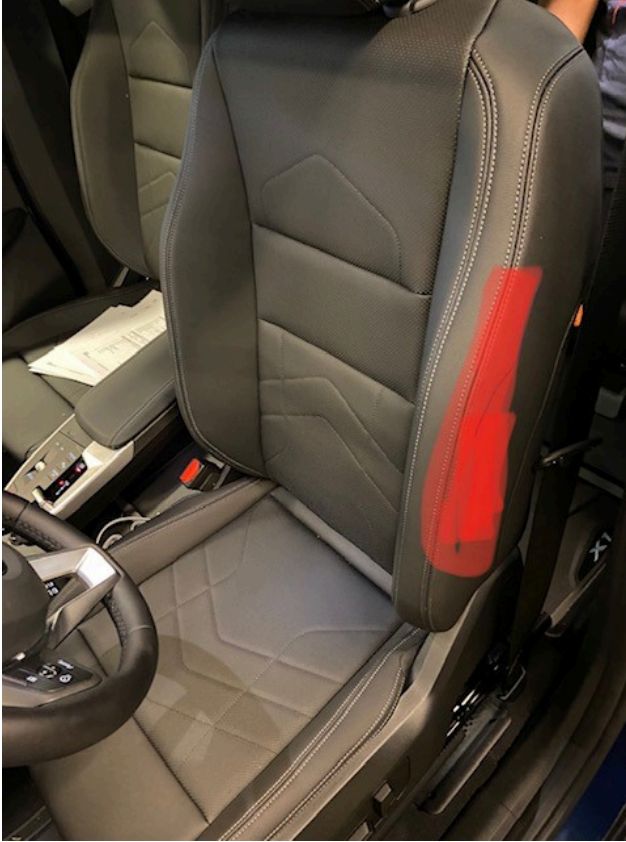
1. Check the resistance of the seat-mounted air bag before seat disassembly.

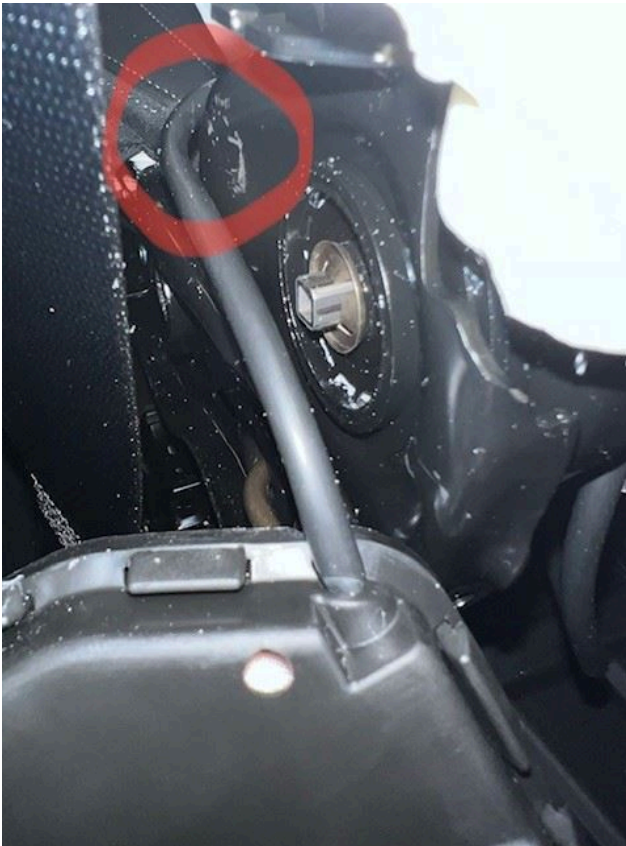
Does the resistance change when sitting in the seat, or moving on the outside seat bolster?

If resistance increases when moving on a particular section the seat, then that is the area to examine the wiring harness.

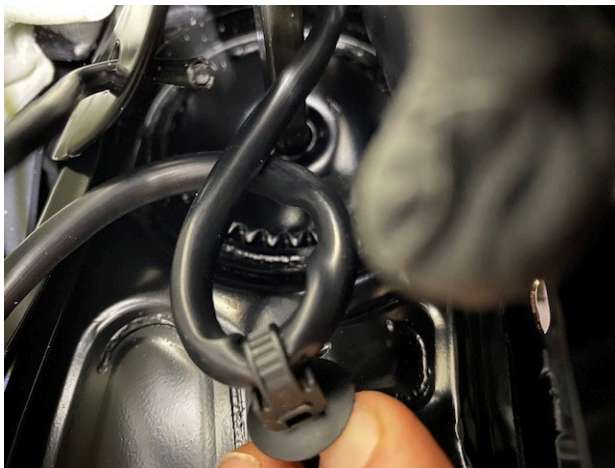
Movement in the seat-mounted air bags’ wiring connector due to the harness being under tension.

Here you can see the harness is pulled tightly around the seat backrest frame and the area where we need to introduce some slack.

3. The harness is held to the back of the seat frame with a push-in clip. You can move this clip on the wiring harness, or move the harness around to introduce more slack.
