SIB 23 01 21

2025-02-13

## DIFFERENTIAL COVER LEAK AT THE REVERSER SHAFT SEAL

Model	Model Description
K48/11	K 1600 GT
K48/12	K 1600 GTL
K61	K 1600 B and Grand America

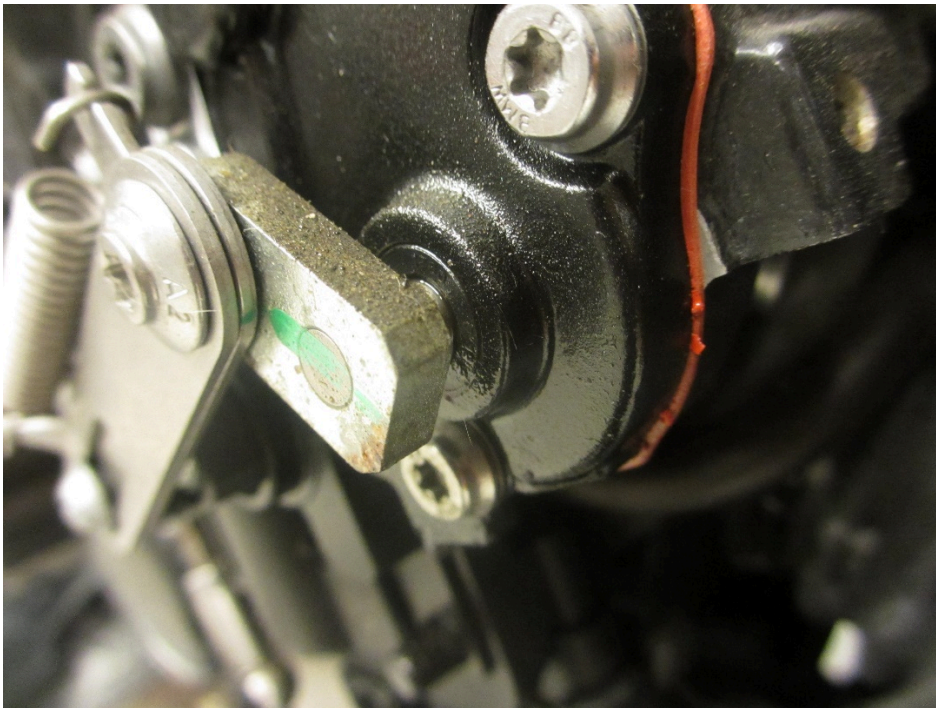
Sealing ring on the differential cover of the reverser is leaking.

Radial shaft seal faulty.

The differential cover of the reverser cannot be serviced by just replacing the sealing ring alone. This is because a special device is required to properly assemble the eccentric shaft with the eccentric lever and bring the lever system into the correct position.

The recommended repair solution is to replace the entire differential cover of the reverser.

If a customer's bike has a leak on the sealing ring of the differential cover, first check to see if replacement differential covers are available. If the differential cover is not available, then the only solution is to replace

the complete transmission assembly.

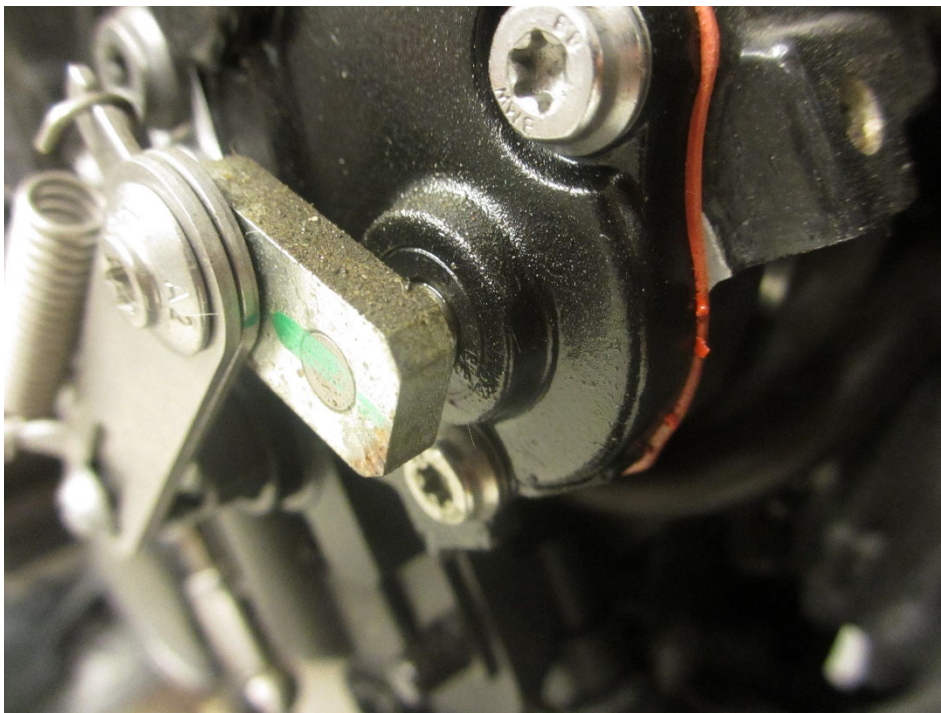
Sealing ring on the differential cover of the reverser is leaking.

Radial shaft seal faulty.

It is not possible to change just the sealing ring in the differential cover of the reverser, as a special device is needed to assemble the eccentric shaft with the eccentric lever in order to bring the lever system into the correct position. The repair solution should be to replace the differential cover of the reverser, but these are currently unavailable.

If a customer bike has a leak on the reverser sealing ring of the differential cover, the current solution is the replacement of the complete transmission assembly.
