## Preview Solution CBR-2431-2

# Volvo Chassis - VN (4) - Crank No Start or Engine Dying Issues

Published 20 February 2025

Volvo Chassis - VN(4)

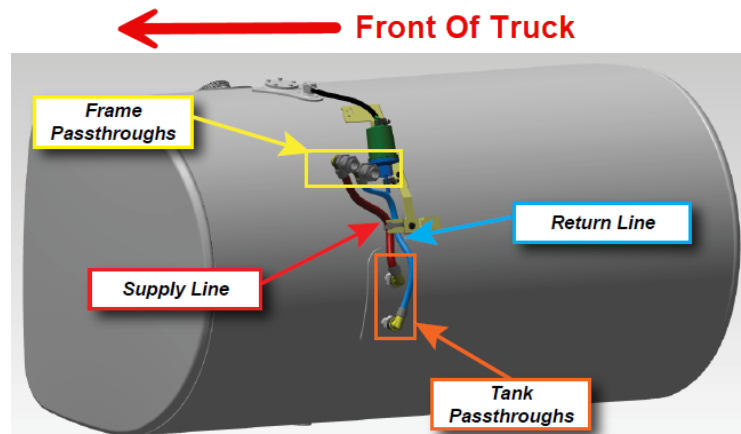
This issue arises when the right-hand fuel tank supply and return fuel lines are improperly connected to the fuel tank. The suction and return lines may be mispositioned at the tank or frame pass-through. This problem may include a corresponding P008A00 fault code.

- » **The top-most tank passthrough must be routed to the front-most frame passthrough**

- » **The bottom-most tank passthrough must be routed to the rear-most frame passthrough**

- If the fuel lines are determined to be mispositioned, reconfigure them to their correct positions (as outlined above)

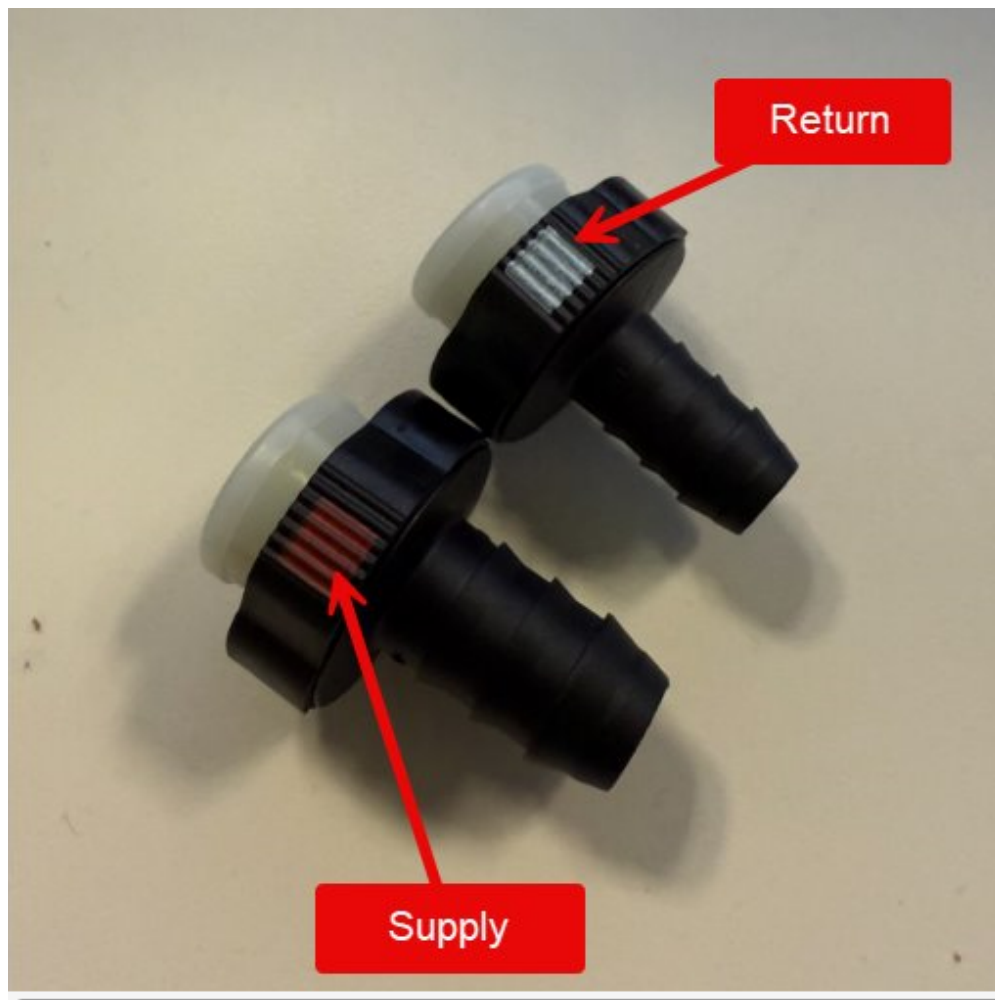
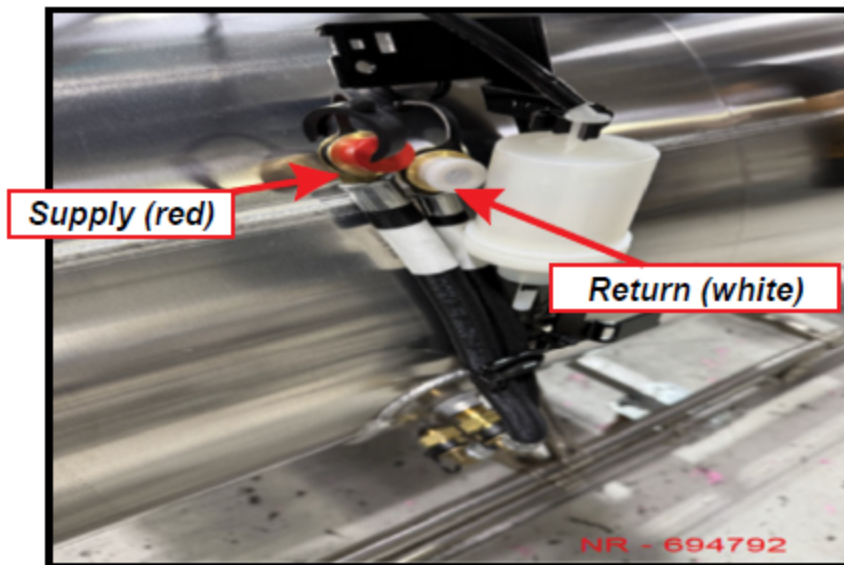
**NOTE:** As pictured below, the Supply and Return lines are fitted with color coded caps and fittings. These color codings may be used to aid in verifying the correct routing.
