## Technical Service Bulletin (TSB) Front Lower Control Arm Stabilizer Link Noise

<b>REFERENCE:</b>	<b>TSB:</b> 02-001-25 <b>GROUP:</b> 02 - Front Suspension	<b>Date:</b>	February 25, 2025	<b>REVISION:</b>	-
<b>VEHICLES AFFECTED:</b>	<b>2019 - 2024 (DT) RAM 1500 Pickup</b> This bulletin applies to vehicles that are not equipped with Front Active Perf Shock Absorbers (Sales Code SFE).			<b>MARKET APPLICABILITY:</b>	
				<input checked="" type="checkbox"/> NA	<input type="checkbox"/> MEA
				<input type="checkbox"/> SA	<input type="checkbox"/> IAP
				<input type="checkbox"/> EE	<input type="checkbox"/> CH
<b>CUSTOMER SYMPTOM:</b>	<b>Customers may experience the following:</b> <ul style="list-style-type: none"> <li>Rattle or clunk noise coming from the front end of the vehicle when driving over bumps, performing turns or during normal operation.</li> </ul>				
<b>CAUSE:</b>	<b>Loose stabilizer link attachment to lower control arm nut</b>

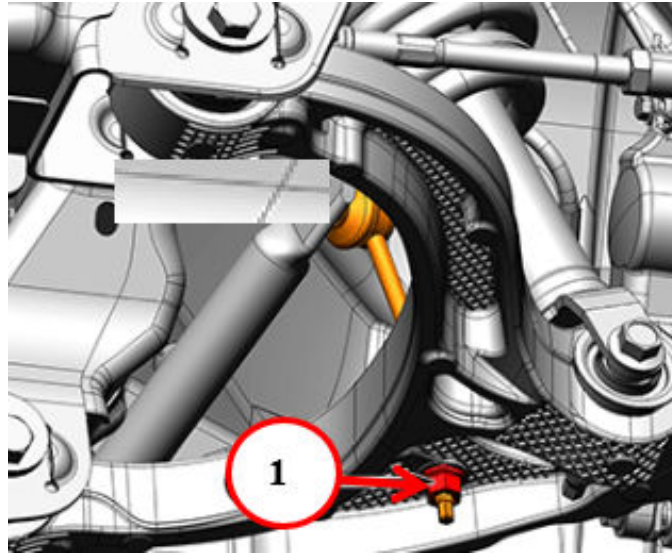
**Fig. 1**  
Lower Stabilizer Link Nut

4. Inspect the stabilizer link attachment to lower control arm nut for the proper tightening torque of 110 N·m (81 Ft. Lbs.) [Fig. 1](#).

1 - Stabilizer Link Attachment To Lower Control Arm Nut

5. Is the stabilizer link attachment to lower control arm nut properly tightened to the torque specification?
  - YES>>> This bulletin does not apply. Perform further diagnosis. Refer to the detailed service procedures available in DealerCONNECT/Service Library under: Service Info> 02 - Front Suspension / Front, Independent Front Suspension / Diagnosis and Testing.
  - NO>>> Proceed to [Step 6](#).
6. Tighten the stabilizer link attachment to lower control arm nut to 110 N·m (81 Ft. Lbs.).
