<p>To: Mercedes-Benz Dealers, General Managers, Sales Managers, Service Managers, Parts Managers</p>	<p>From: Anthony Washington, Senior Manager, Regulations and Certifications</p>
<p>Re: Service Campaign Notification Model: Metris Model Year: 2021 Replace Longitudinal Member Weld Nuts</p>	<p>Date: February 2025</p>

IMPORTANT SERVICE CAMPAIGN INFORMATION

Campaign No.:	Campaign Desc.:	NHTSA ID:	Replace Longitudinal Member Weld Nuts
2025020011	VS2SPANBA	N/A	
This is to notify you of a Service Campaign to replace weld nuts on the longitudinal member on 1 MY 2021 Metris Van. All affected VINs will be flagged as "OPEN" in VMI			
Background			
Issue	Mercedes-Benz AG, the manufacturer of Mercedes-Benz Metris Vans, has determined that the weld nuts on the longitudinal member were not installed according to current production specifications.		
What We're Doing	MBUSA is conducting a service campaign. An authorized Mercedes-Benz dealer will replace and install new weld nuts on the longitudinal member.		
Parts	Part is available.		
Vehicles Affected			
Model Year(s)	2021		
Vehicle Model	Metris		
Vehicle Populations			
Total Vehicles	1		
Dealer Inventory	0		
Next Steps/Notes			
AOMS/SOMS	Pleas

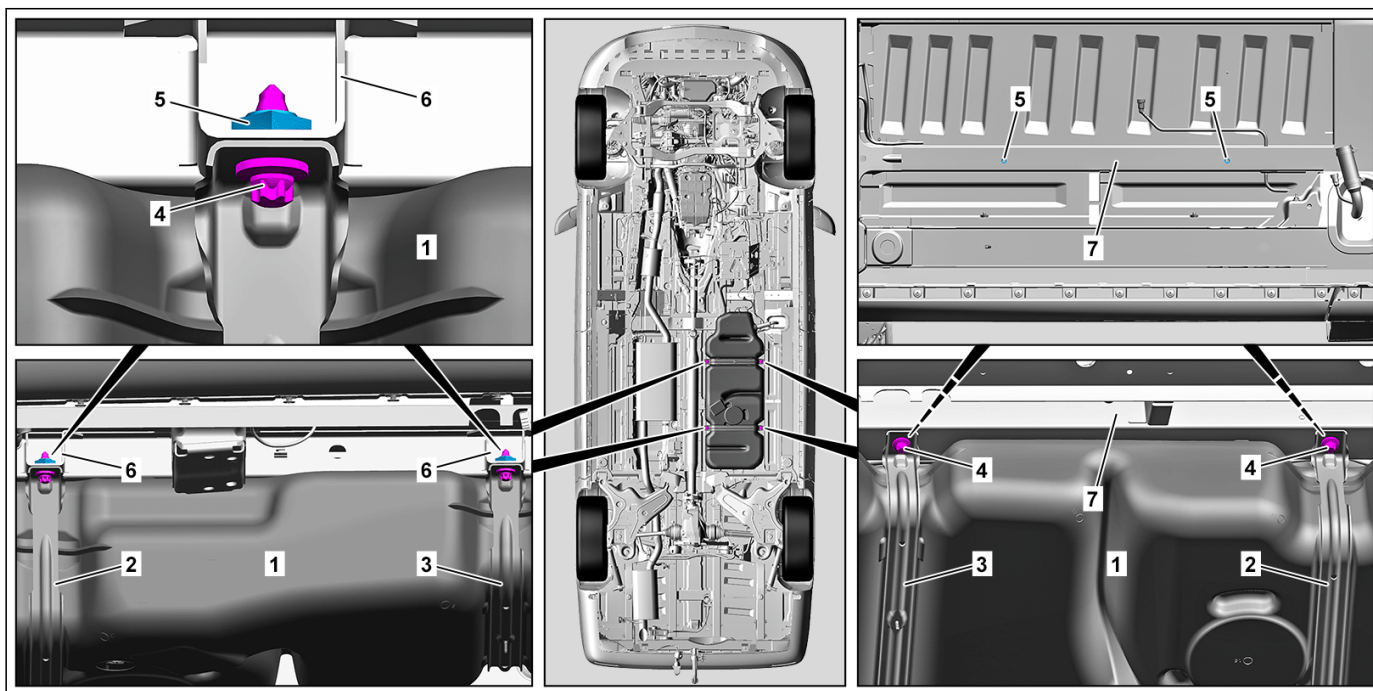
S61.10-A098-79

4	Check whether thread of respective weld nut (5) and screw (4) on rear retaining bracket (2) and front retaining bracket (3) is damaged.	<p>ⓘ When checking the respective weld nut (5), it must not be possible to unscrew the screws (4) sluggishly and there must not be any visible damage to the thread. If one of the screws (4) unscrews sluggishly or if there is visible damage to the thread, replace respective weld nut (5) and screw (4). Otherwise, the correct torque of the respective screws (4) cannot be guaranteed.</p> <p>ⓘ At least one of the four following weld nuts (5) is damaged and must be replaced. Otherwise, correct mounting of the rear retaining bracket (2) or front retaining bracket (3) cannot be guaranteed.</p> <p>ⓘ To do so, unscrew screws (4) from rear retaining bracket (2) and front retaining bracket (3). If the screw (4) can be unscrewed sluggishly or if there is visible damage to the thread,</p> <p style="text-align: center;">↓</p> <p>replace respective damaged weld nut (5) with corresponding screw (4); to do so, continue with operation step 5.</p> <p>If it is not possible to determine whether the screw (4) can be unscrewed sluggishly or if there is any damage to the thread without error,</p> <p style="text-align: center;">↓</p> <p>replace all weld nuts (5) with corresponding screws (4); to do so, continue with operation step 5.</p>

Replace respective weld nut (5)
