### Check engine light or Adblue warning with fault codes P206B31, P203B31, or P300494 when outside temperatures are below 32 degrees Fahrenheit

| Topic number | LI49.20-N-078838 |
| Function group | 49.20 - Exhaust gas aftertreatment |
| Validity | Model 907 |

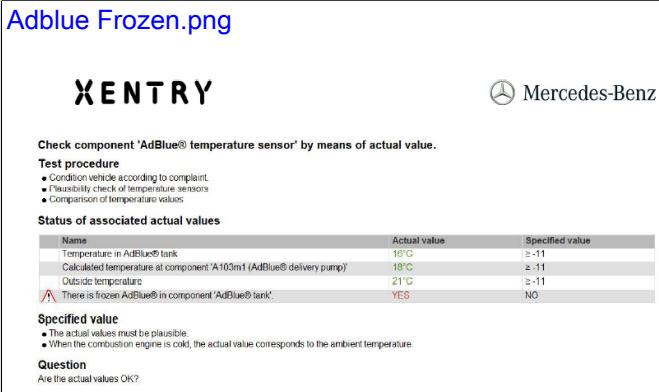
| Attachments | |
|---|---|
| <div><a href="#">Adblue Frozen.png</a></div> <div></div> <div>Adblue Frozen</div> | |

--NOTE-- If the XENTRY still shows that there is frozen Adblue or the concentration is still inaccurate after draining and filling, please refer to the attachments 'Adblue Frozen' and 'Adblue Concentration' and proceed to step C.

<table><tr><th>No.</th><th>Name</th><th>Actual value</th><th>Specified value</th></tr><tr><td>846</td><td>There is frozen AdBlue® in component 'AdBlue® tank'</td><td>YES</td><td>NO</td></tr></table>
