Technical Service Bulletin (TSB)
Power Running Board Trim Paint Peeling

REFERENCE:	TSB: 23-010-25 GROUP: 23 - Body	Date:	February 28, 2025	REVISION:	-
VEHICLES AFFECTED:	2022 - 2024 (WS) Grand Wagoneer/Wagoneer This bulletin applies to vehicles equipped with Power Deployable Running Boards (Sales Code MY7) and Exterior Accents-Piano Black (Sales Code MHY) .	MARKET APPLICABILITY:			
		<input checked="" type="checkbox"/> NA <input type="checkbox"/> CH <input type="checkbox"/> EE <input type="checkbox"/> IAP <input type="checkbox"/> SA <input type="checkbox"/> MEA			
CUSTOMER SYMPTOM:	The customer may comment on the following: <ul style="list-style-type: none"> Power running board black trim paint peeling Fig. 1 and Fig. 2. 				
CAUSE:	Material defect

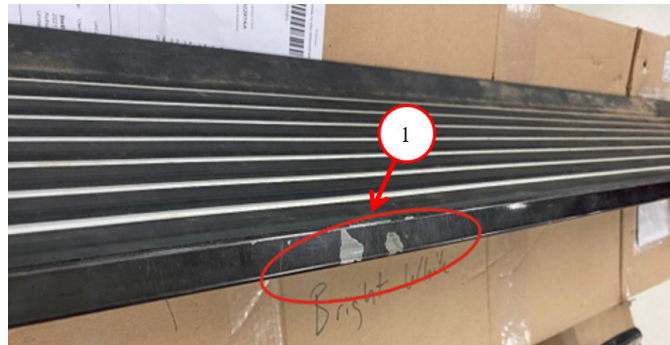
Fig. 1
Paint Peeling Example

1 - Evidence Of Paint Peeling

1. Replace the power running board step assembly. Refer to the detailed service procedures listed in DealerCONNECT> Service Library under: 23 - Body / Exterior / Step, Side / Removal and Installation.

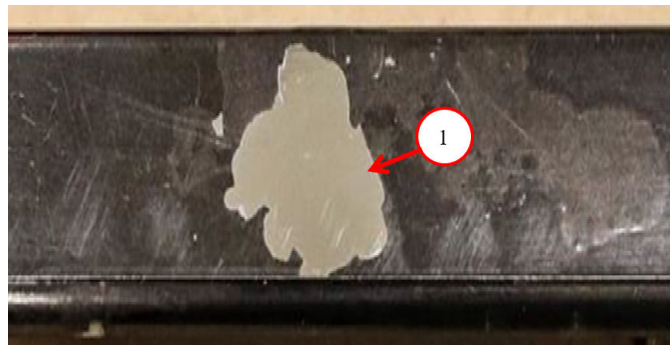
Fig. 2
Paint Peeling Example

1 - Evidence Of Paint Peeling
