# 26-006 DT12 Excessive Wear

## TSB-26-006-WST

Creation Date: 2025-02-04

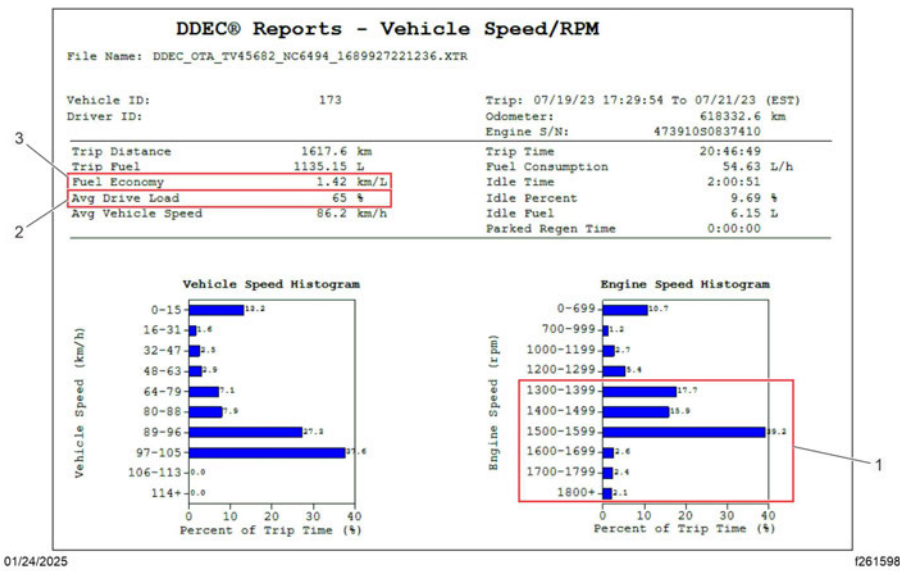
Fig. 1, Highlighted Wear Factors in DDEC Reports

The factors that indicate a severe duty transmission application may experience high wear rates are listed below. Using DDEC Reports, it is possible to identify vehicles exposed to these factors at a level that may impact transmission life. See Fig. 1. These factors include high average revolutions per minute (rpm), engine loads, low fuel economy, high Gross Combined Vehicle Weights (GCVW), and are all typically above the levels listed below.

- Total percent of trip time, for engine speed over 1,300 rpm, greater than 40%.
- Average drive load greater than 40%.
- Fuel economy less than 4 mpg (1.7 km/L).
- Hauling greater than 160,000 lbs (72,640 kg).

1. Total percent of trip time, for engine speed over 1,300 rpm, greater than 40%.
2. Average drive load greater than 40%.
3. Fuel economy less than 4 mpg (1.7 km/L).

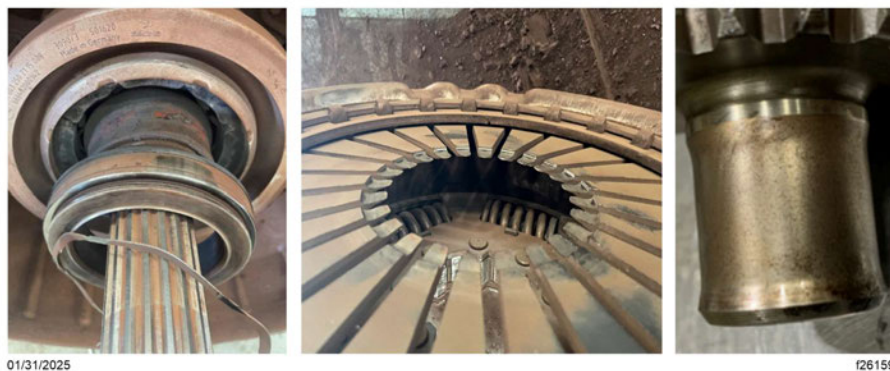
Fig. 2, Examples of CPCA, Clutch, and Input Shaft Wear

Select components are affected when the wear factors are near threshold levels, and typically, most/all will show signs of wear in these applications. See Fig. 2.

- Clutch release bearing retainer ring damage and/or clutch contact surface wear on the Concentric Pneumatic Clutch Actuator (CPCA).
- Clutch diaphragm finger wear, broken damper springs, and/or worn spring pockets.
- Pilot bearing and input shaft tip wear.
- Loss of bearing preload.
- Transmission main and counter shaft.

As these components wear, the rate of wear also increases. If the components are replaced or adjusted before the wear becomes too excessive, the life expectancy of transmissions in these applications can be significantly extended.

Each application may be different, but it is common to see significant wear developing around 190,000 miles (305,710 km). For vehicles exposed to this level of loading, this may be a good time to replace worn components and adjust bearing preloads.
