# 26-055 DT12 Excessive Wear

# TSB-26-055-FTL

► New Cascadia

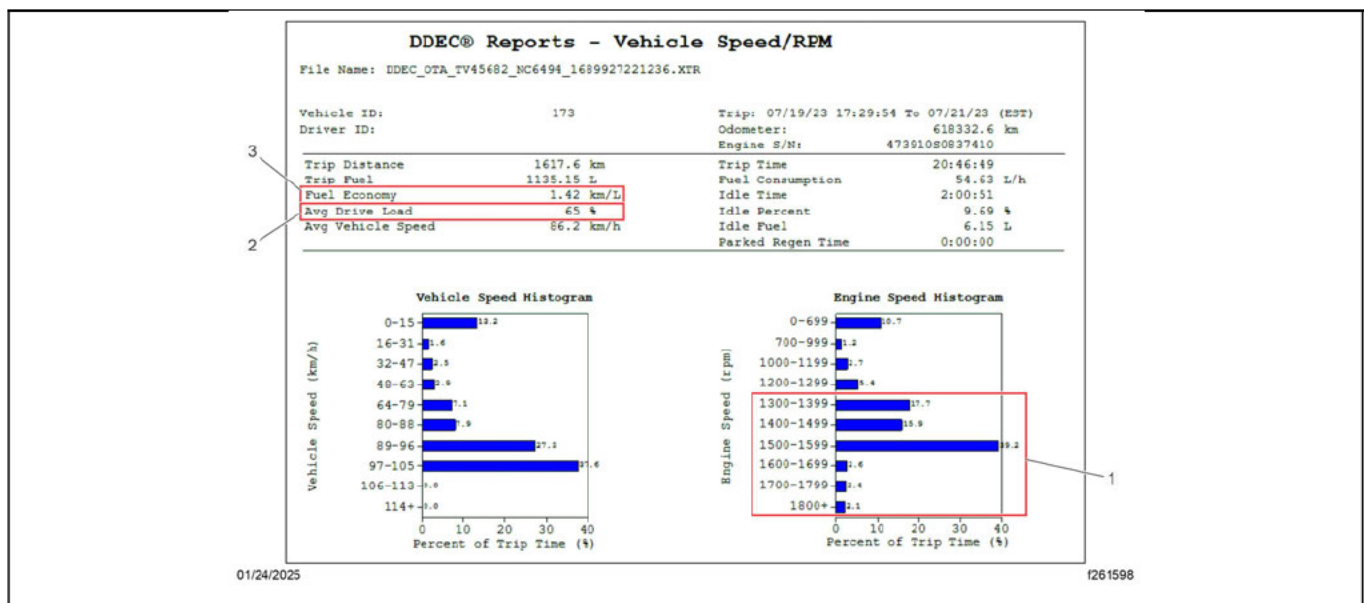
Fig. 1, Highlighted Wear Factors in DDEC Reports

The factors that indicate a severe duty transmission application may experience high wear rates are listed below. Using DDEC Reports, it is possible to identify vehicles exposed to these factors at a level that may impact transmission life. See Fig. 1. These factors include high average revolutions per minute (rpm), engine loads, low fuel economy, high Gross Combined Vehicle Weights (GCVW), and are all typically above the levels listed below.

- Total percent of trip time, for engine speed over 1,300 rpm, greater than 40%.
- Average drive load greater than 40%.
- Fuel economy less than 4 mpg (1.7 km/L).
- Hauling greater than 160,000 lbs (72,640 kg).

1. Total percent of trip time, for engine speed over 1,300 rpm, greater than 40%.
2. Average drive load greater than 40%.
3. Fuel economy less than 4 mpg (1.7 km/L).

In addition to understanding the factors that contribute to this level of wear, customers in these applications should also follow the shortest fluid service maintenance interval for the application. For specific details, see the *Transmission Fluid Service Information* manual.

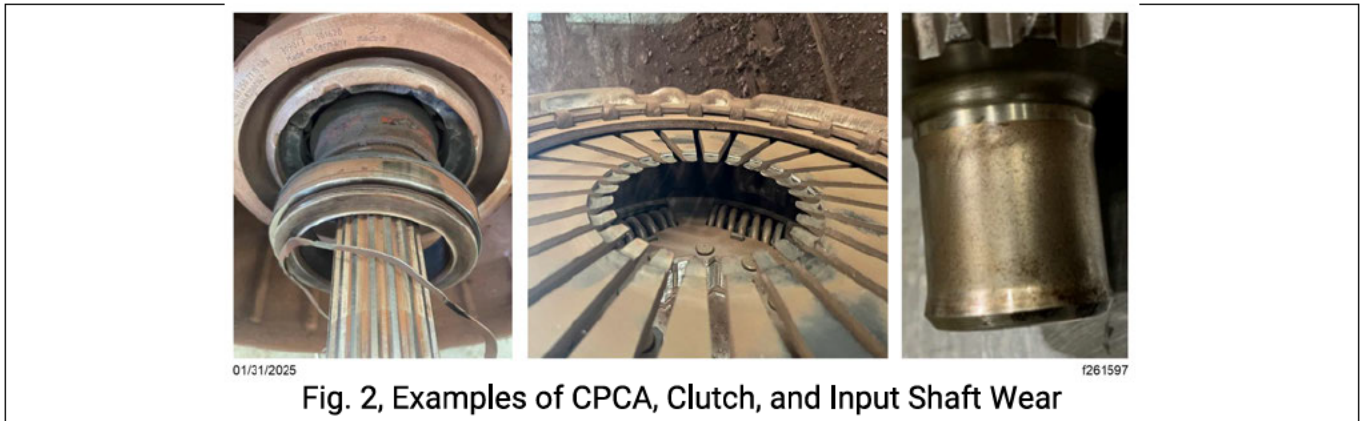
Fig. 2, Examples of CPCA, Clutch, and Input Shaft Wear

Select components are affected when the wear factors are near threshold levels, and typically, most/all will show signs of wear in these applications. See Fig. 2.

- Clutch release bearing retainer ring damage and/or clutch contact surface wear on the Concentric Pneumatic Clutch Actuator (CPCA).
- Clutch diaphragm finger wear, broken damper springs, and/or worn spring pockets.
- Pilot bearing and input shaft tip wear.
- Loss of bearing preload.
- Transmission main and counter shaft.

Besides the list of components that exhibit wear, transmissions exposed to this level of loading may eventually have a catastrophic failure with abnormal metal present in the sump, and/or contact between the main shaft speed sensor and the tone ring due to the main shaft movement. As the wear approaches this level, it is no longer manageable with shim adjustments and component replacement; transmission replacement is the only option.

As these components wear, the rate of wear also increases. If the components are replaced or adjusted before the wear becomes too excessive, the life expectancy of transmissions in these applications can be significantly extended.

Each application may be different, but it is common to see significant wear developing around 190,000 miles (305,710 km). For vehicles exposed to this level of loading, this may be a good time to replace worn components and adjust bearing preloads.
