54-096 Connect 5 Instrument Cluster (ICC5) Nuisance Fault Code

TSB-54-096-WST

Engine or Vehicle Affected:

- ▶ 47X
- ▶ 49X
- ▶ 57X

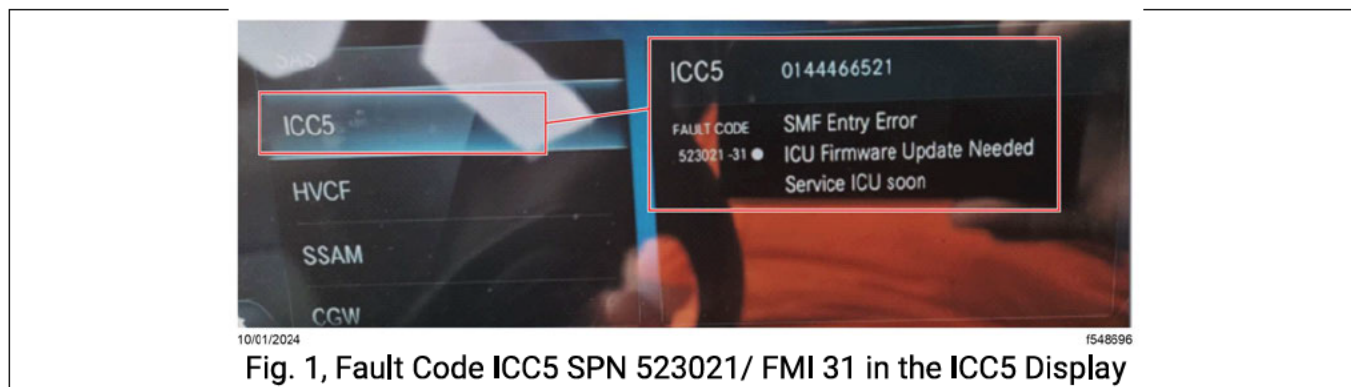
Vehicles equipped with a Connect 5 Instrument Cluster (ICC5) and ordered with the software package identified by sales codes 81Z-008, 81Z-308, or 81Z-808 (related to model year 2023 or software version 22.50.30) may display the fault code 'ICC5 SPN 523021/ FMI 31 - The list of Electronic Control Units (ECUs) in the Warning Database (WDB) does not match the list of ECUs parameterized in PID 0x20.' This is considered a nuisance code and does not require any troubleshooting or programming changes.

Figure 1 shows what the fault code 'ICC5 SPN 523021/ FMI 31' looks like on the ICC5 display.
