54-097 SAS01T to SAS03T Replacement Information

TSB-54-097-WST

Creation Date: 2025-02-04

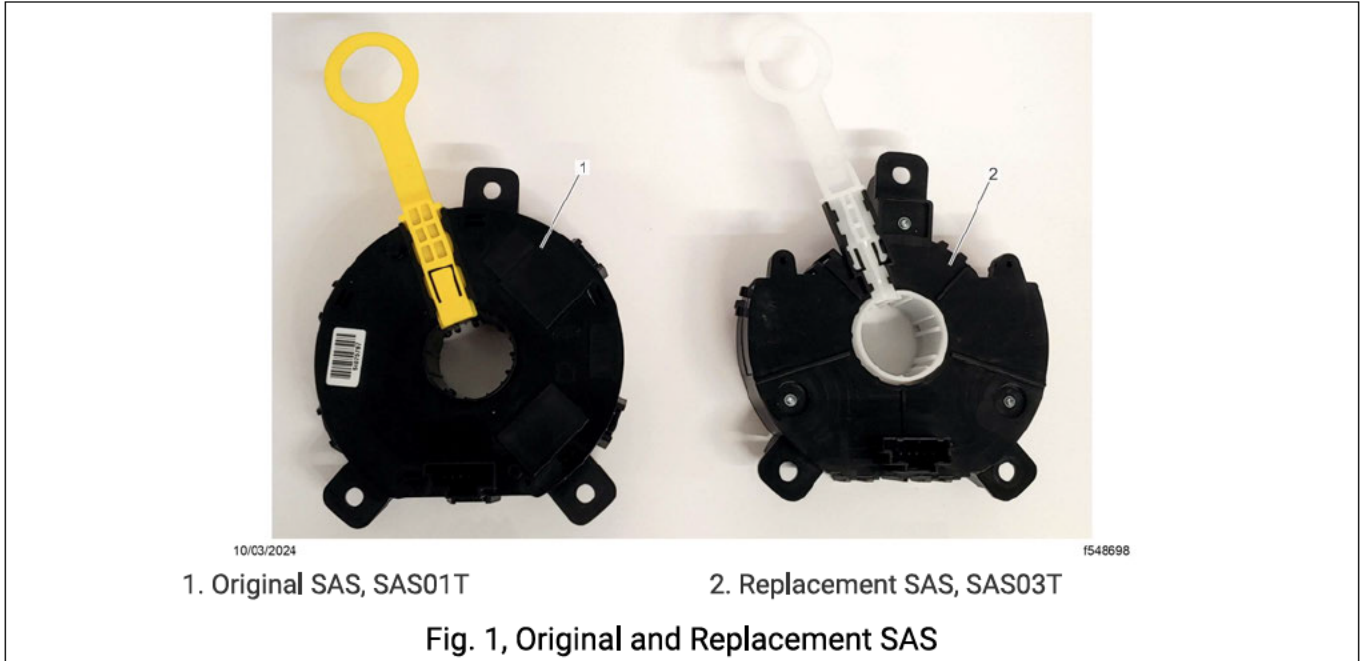
The SAS03T appears slightly different compared to the SAS01T as shown in Fig. 1. However, the process of replacing and mounting the SAS remains the same. For instructions, see **Group 20** of the applicable workshop manual.

When replacing the original SAS01T, see Table 1 to find the new replacement part SAS03T.

Chassis CAN Baud Rate	Original Part Number (SAS01T)	Replacement Part Number (SAS03T)
500kb Chassis CAN	A14-19418-000	A14-21040-307
667kb Chassis CAN	A14-20044-000	A14-21040-106

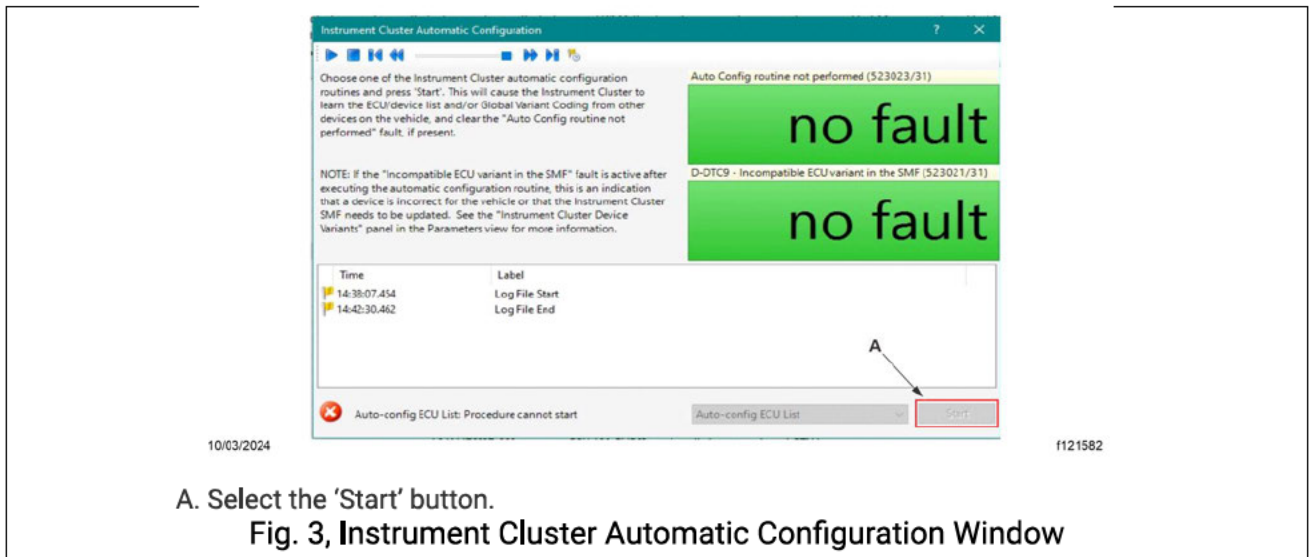
Fig. 3, Instrument Cluster Automatic Configuration Window

6. The 'Instrument Cluster Automatic Configuration' window opens. Select 'Start' to run the auto-configuration. See Fig. 3. Does the fault code 'SA 23 SPN 523021/FMI 31' appear after running the auto configuration?

YES → It is required to program the CGW04T. Go to step 7.

A. Select the 'Start' button.
