54-372 Connect 5 Instrument Cluster (ICC5) Nuisance Fault Code

TSB-54-372-FTL

- ▶ Business Class M2-Plus
- ▶ 108SD Plus/114SD Plus
- ▶ Cascadia

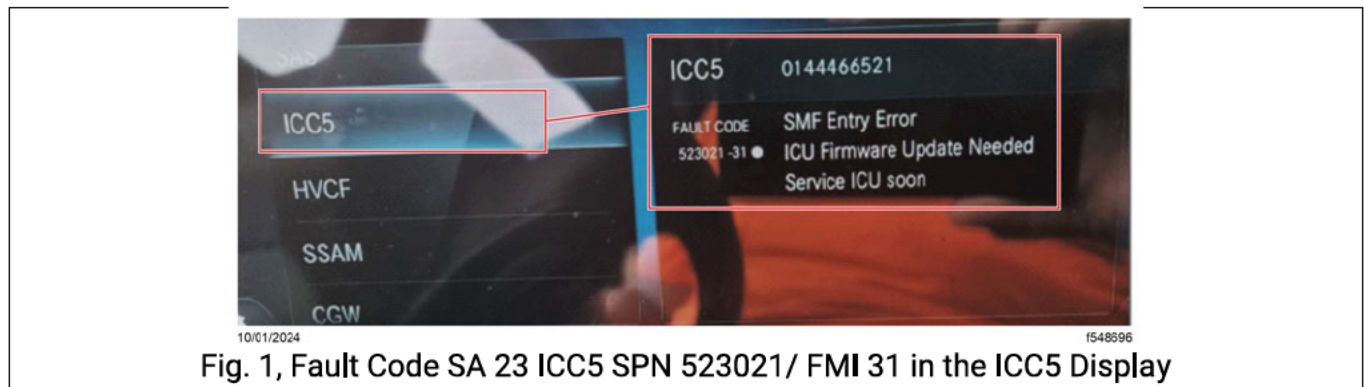
Vehicles equipped with a Connect 5 Instrument Cluster (ICC5) and ordered with the software package identified by sales codes 81Z-008, 81Z-308, or 81Z-808 (related to model year 2023 or software version 22.50.30) may display the fault code 'SA 23 ICC5 SPN 523021/ FMI 31 - The list of Electronic Control Units (ECUs) in the Warning Database (WDB) does not match the list of ECUs parameterized in PID 0x20.' This is considered a nuisance code and does not require any troubleshooting or programming changes.

Figure 1 shows what the fault code 'SA 23 ICC5 SPN 523021/ FMI 31' looks like on the ICC5 display.
