54-373 SAS01T to SAS03T Replacement Information

TSB-54-373-FTL

Creation Date: 2025-02-04

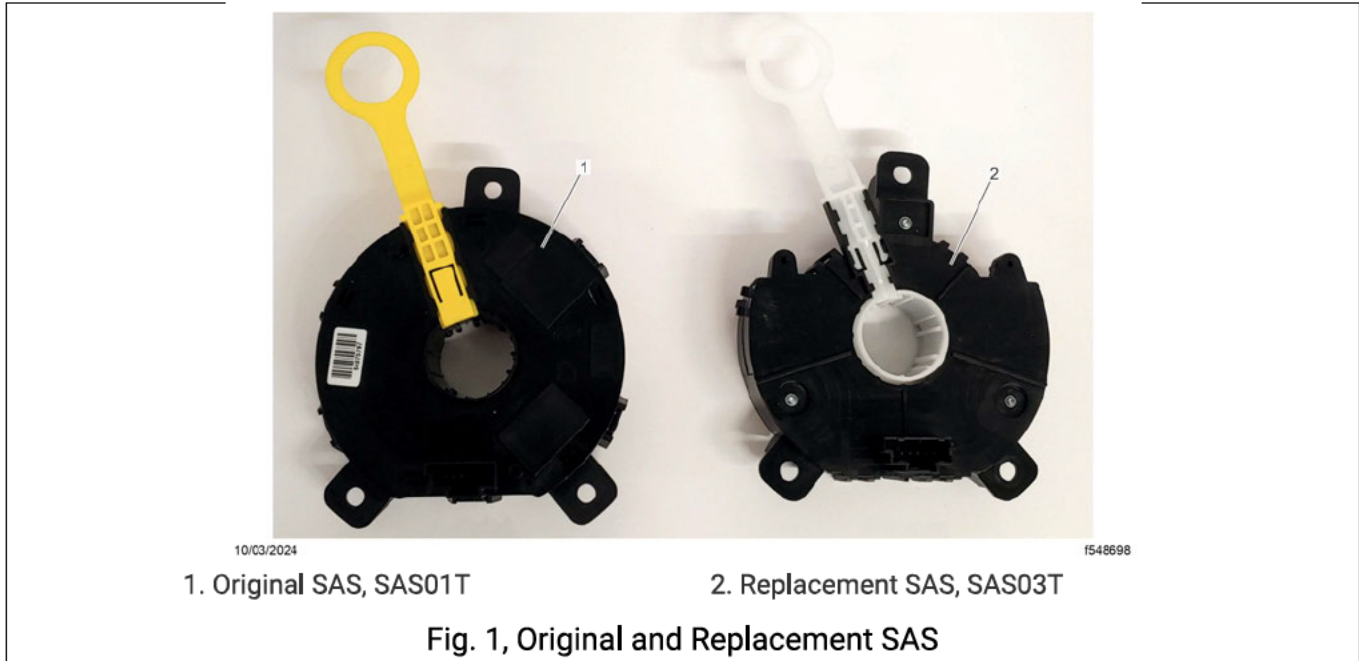
The SAS03T appears slightly different compared to the SAS01T as shown in Fig. 1. However, the process of replacing and mounting the SAS remains the same. For instructions, see **Group 20** of the applicable workshop manual.

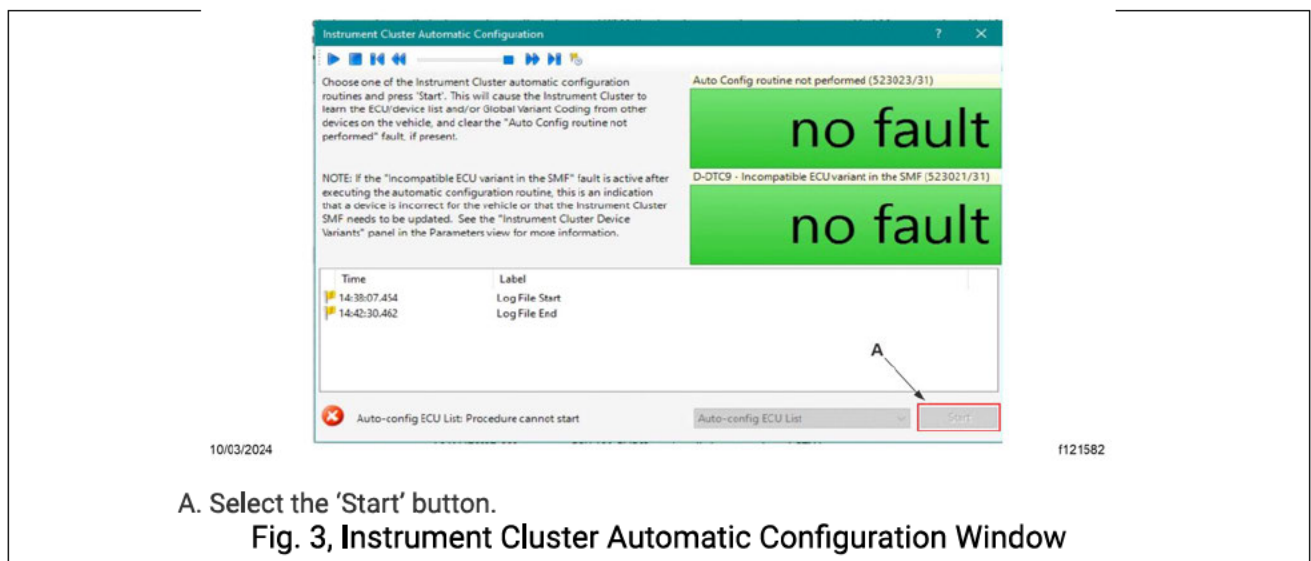
Fig. 3, Instrument Cluster Automatic Configuration Window

6. The 'Instrument Cluster Automatic Configuration' window opens. Select 'Start' to run the auto-configuration. See Fig. 3. Does the fault code 'SA 23 SPN 523021/FMI 31' appear after running the auto configuration?

A. Select the 'Start' button.
