# Technical Service Bulletin

Mazda North American Operations  
Irvine, CA 92618-2922

<b>Subject:</b>  VIBRATION WHEN DRIVING AT 1500-1650 RPM	<b>Bulletin No.:</b> 01-001/25
	<b>Last Issued :</b> 02/06/2025

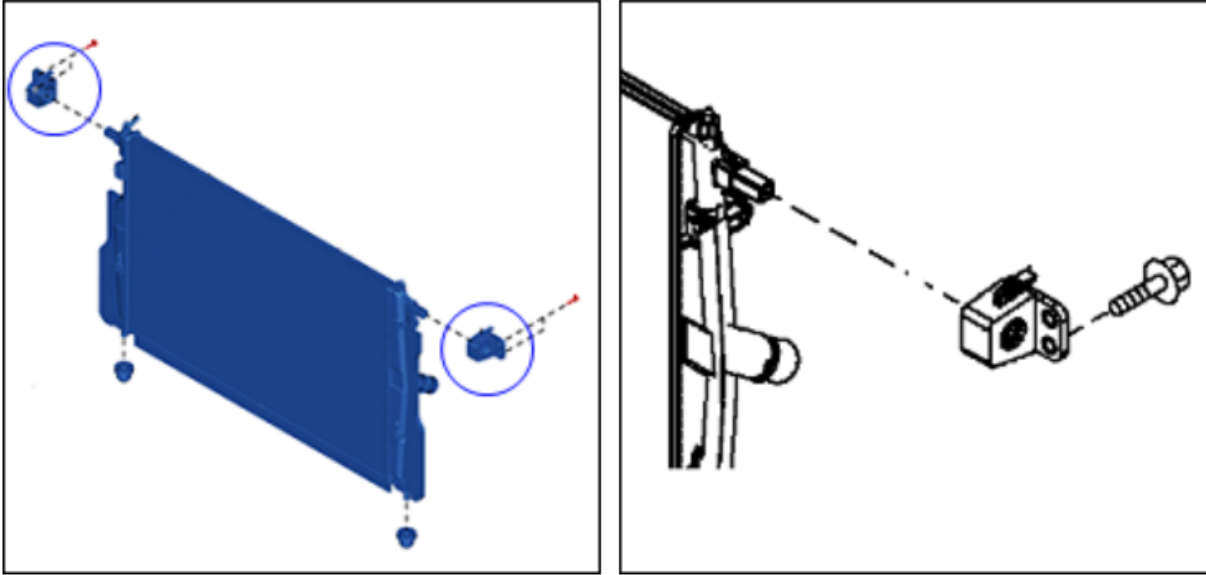
To correct this concern, the radiator mount brackets and the control software of the PCM have been modified to reduce the resonance of the radiator.

2. Replace the radiator mount brackets with modified ones.

**Bolt tightening torque: 71-88 in-lb (82-101 kgf-cm, 8-10 Nm)**
