SS 770 WST 47X/49X Dual Power Steering Gear Orifice Fittings

Western Star 47X, 48X, 49X vehicles configured with dual power steering gears.

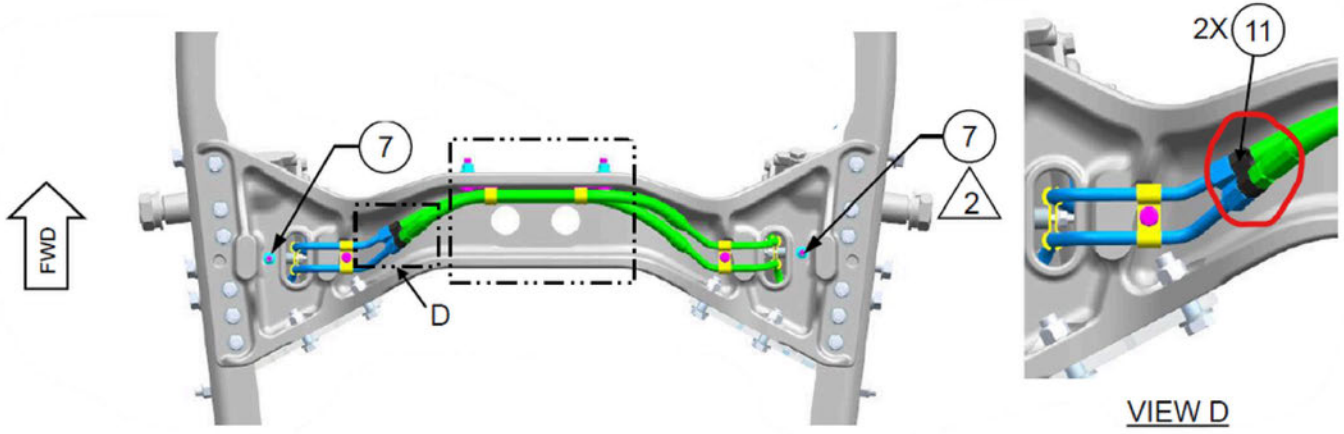
Set Forward Axle Configuration

The location of the orifice fittings can be identified by the diagrams below. Set Forward Axle vehicles have the fittings installed below the front engine cross member. Set Back Axle vehicles have the fittings installed at the auxiliary steering gear.
