SS 3172-FTL Tire Pressure Monitoring System (TPMS) Water Intrusion Through Perimeter Seal

New Cascadia M2 Plus, 108SD Plus and 114SD Plus Vehicles, with J1939 500K Baud Rate Bendix TPMS built 10/1/2021 to 1/28/2025.

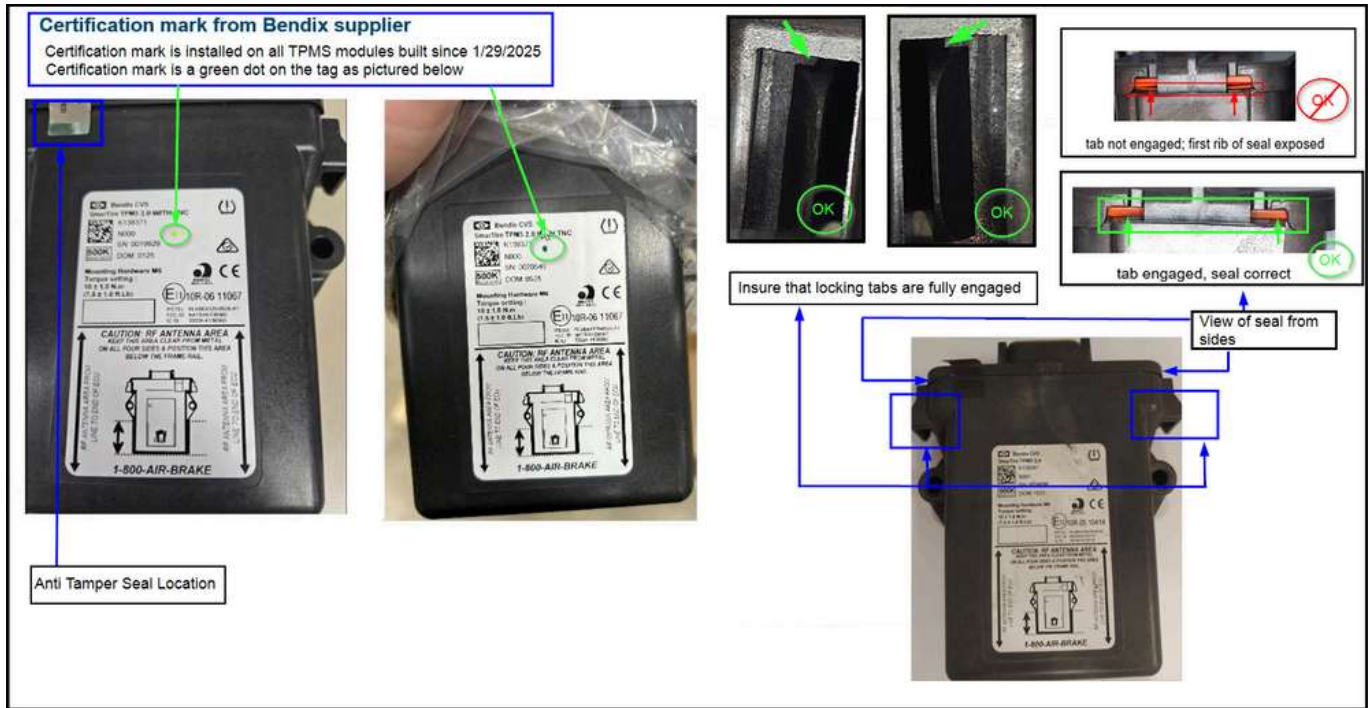
Figure 1

The updated improvement to the perimeter seal requires more force to fully seat the perimeter seal and latch the front cover of the TPMS to the housing. Failure to fully latch the cover to the housing can result in water intrusion into the TPMS module.

If encountering either of the symptoms listed above, and it is determined that the TPMS module is the cause, upon replacing the module inspect the TPMS module to see if the front cover latches are fully engaged and inspect the perimeter seal to see if any of the ribs from the seal can be seen, reference figure 1. If either front cover latch is found to not be fully engaged, and or the perimeter seal is showing a single rib or multiple ribs exposed, then if the vehicle is still under warranty, and warranty claim is being submitted, make sure to include this solution number in the claim.

Last, before installing any new TPMS module, visually inspect both front cover latches ensuring they fully engaged along with making sure none of the perimeter seal ribs are showing. Also note if the certification mark (green dot) is present. If either ribs are showing and or the latches are not fully engaged, do not attempt to alter the module (as an anti-tamper seal is installed), but rather return the module back as a parts warranty including this service solution and noting if the certification mark was present. Do not install any TPMS module that does not pass these inspections.
