Technical Service Bulletin

SUNROOF RATTLE NOISE

Bulletin No.: 09-010/25

2023-2025 CX-50

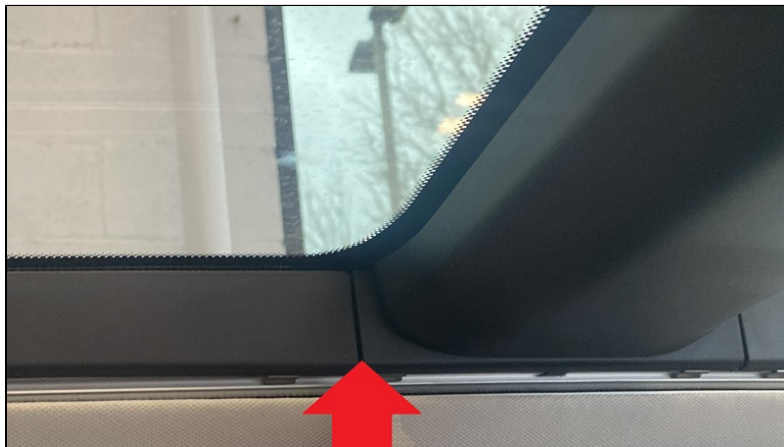
The noise comes from the side cover vibrating against the assembly at the location marked by the arrow due to poor retention of the cover clips.

1. Test drive the vehicle and if you hear the noise, press the edges of the side covers (6 total) as shown in the example below.

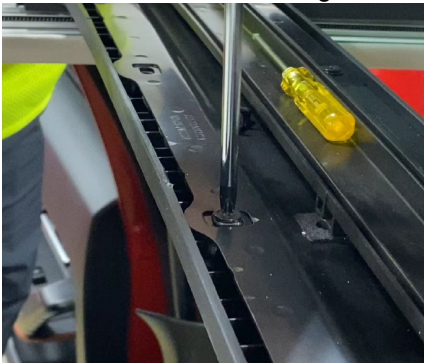
The noise comes from the cross brace cover after the vehicle has been driven and the clips loosen. Follow the instructions below to eliminate the noise.

3. Remove the pushpins and then remove the trim.

CAUTION: DO NOT damage the trim as it is only available with the sunroof assembly.

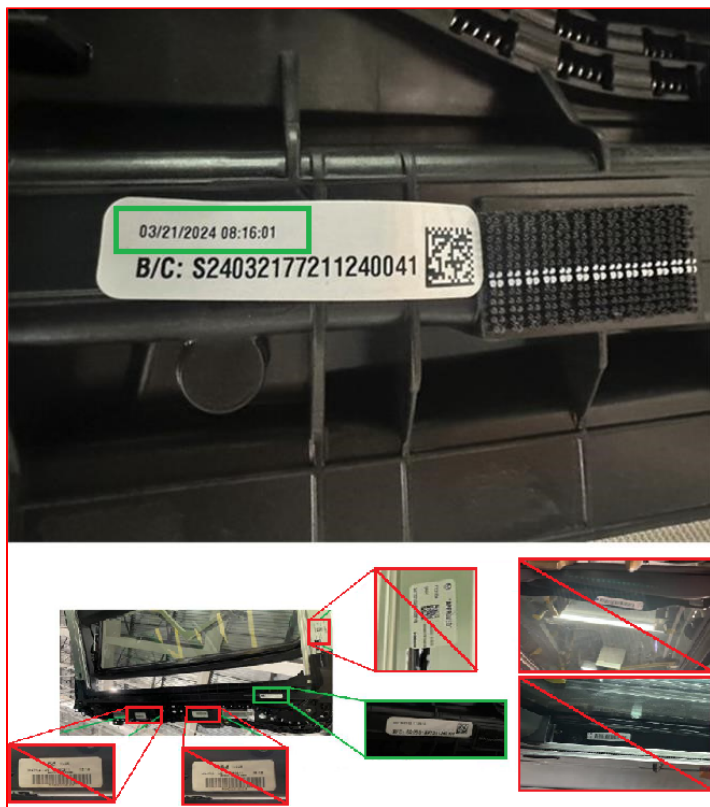
1. Remove the headliner using the relevant steps from the PANORAMA SUNROOF UNIT REMOVAL procedure.
2. Check the sunroof assembly date by inspecting the label marked in green in the image below, the date is written in MM/DD/YYYY format.

**Was the sunroof produced before 12/07/2022?**

- **YES:** Replace the sunroof unit using the instructions in MGSS (PANORAMA SUNROOF UNIT REMOVAL and PANORAMA SUNROOF UNIT INSTALLATION).
- **NO:** Continue to the next section to check the sunroof mounting.

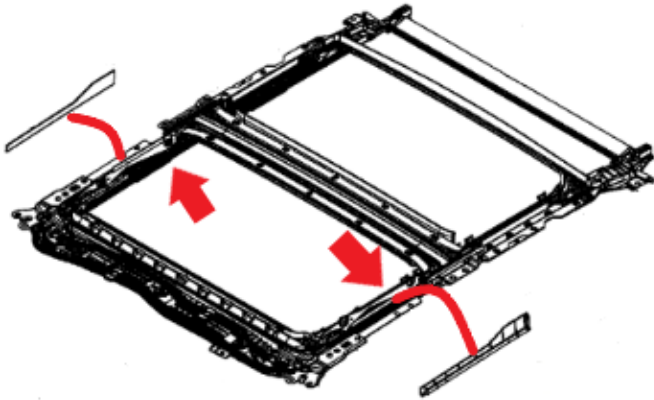
1. Remove the side cover at the front of the assembly to eliminate it as a possible noise source and for better access to the sunroof linkage.
2. Drive the vehicle with the sunroof open and confirm if a rattle is coming from the linkage in the general areas the red arrows point to.

NOTE: If you can reach the links that are rattling, you can hold them to confirm if the noise is eliminated.

YES: Replace the sunroof unit.
