SS 780-WST Tire Pressure Monitoring System (TPMS) Water Intrusion Through Perimeter Seal

All X-series Western Star vehicles, with J1939 500K Baud Rate Bendix TPMS built 10/1/2021 to 1/28/2025.

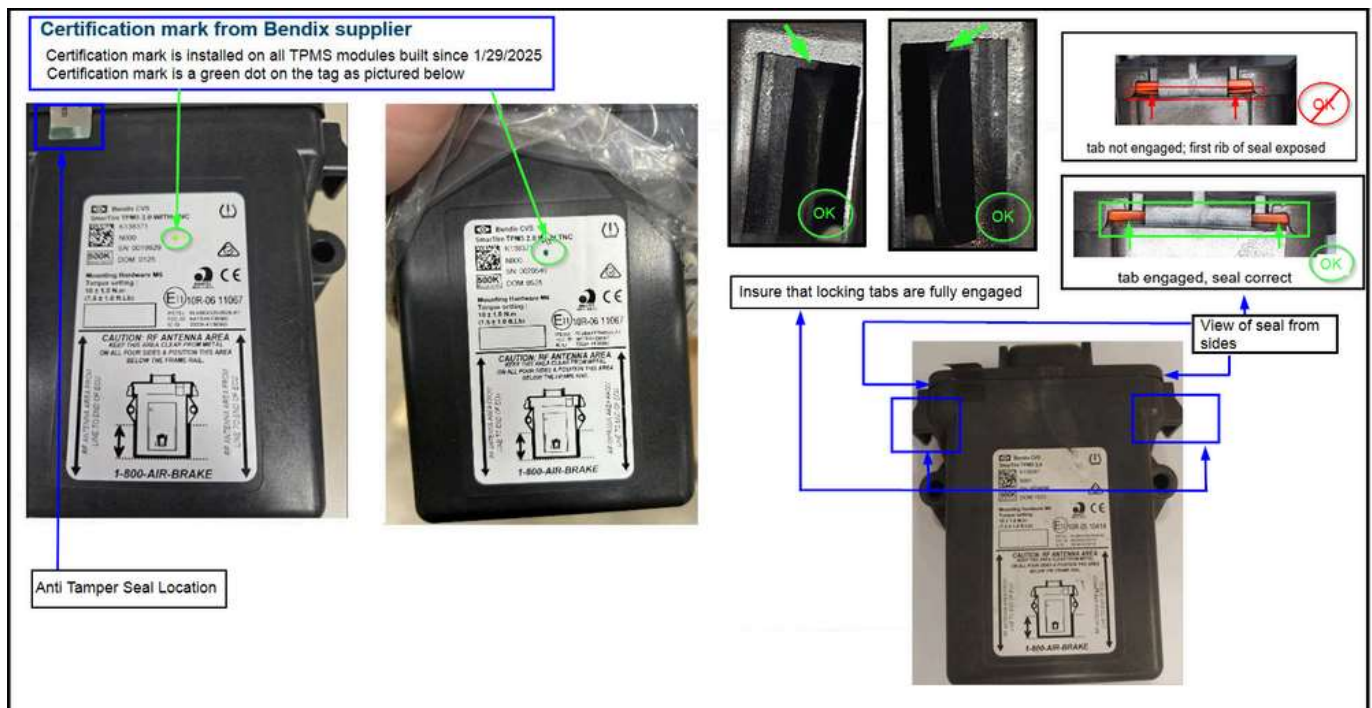
Figure 1

The updated improvement to the perimeter seal requires more force to fully seat the perimeter seal and latch the front cover of the TPMS to the housing. Failure to fully latch the cover to the housing can result in water intrusion into the TPMS module.

If encountering either of the symptoms listed above, and it is determined that the TPMS module is the cause, upon replacing the module inspect the TPMS module to see if the front cover latches are fully engaged and inspect the perimeter seal to see if any of the ribs from the seal can be seen, reference figure 1. If either front cover latch is found to not be fully engaged, and or the perimeter seal is showing a single rib or multiple ribs exposed, then if the vehicle is still under warranty, and warranty claim is being submitted, make sure to include this solution number in the claim.

Last, before installing any new TPMS module, visually inspect both front cover latches ensuring they fully engaged along with making sure none of the perimeter seal ribs are showing. Also note if the certification mark (green dot) is present. If either ribs are showing and or the latches are not fully engaged, do not attempt to alter the module (as an anti-tamper seal is installed), but rather return the module back as a parts warranty including this service solution and noting if the certification mark was present. Do not install any TPMS module that does not pass these inspections.
