Gen 5 DD13 Turbocharger Oil Return Line Cracks

TSB-01-002-DDC

▶ DD13

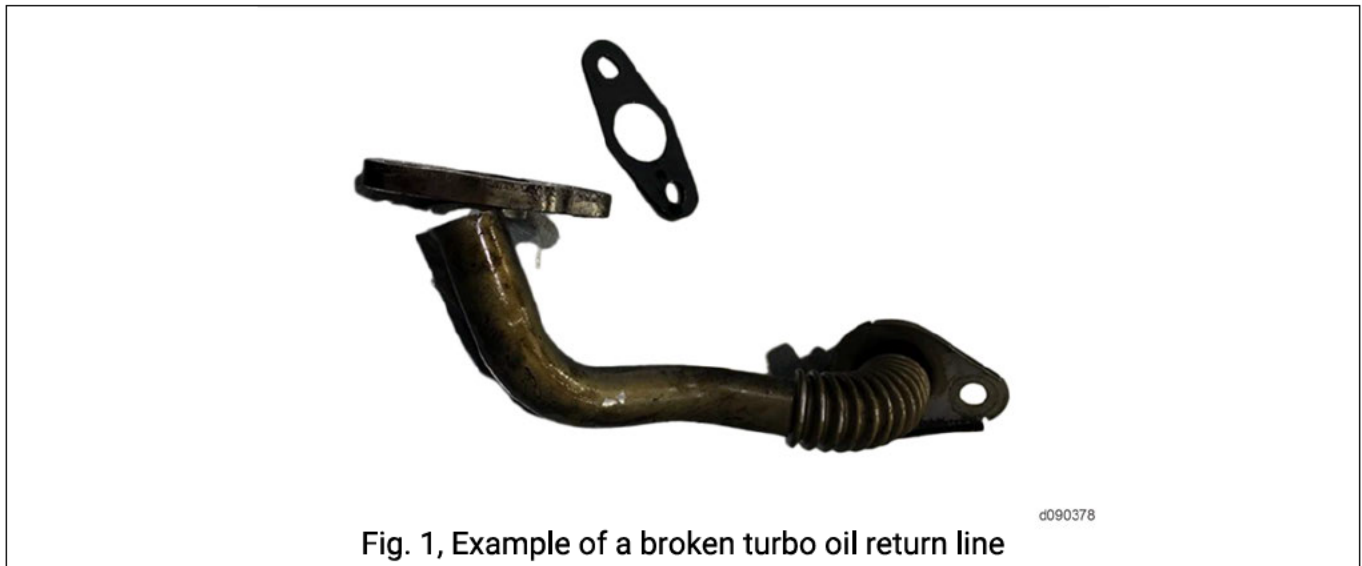
Fig. 1, Example of a broken turbo oil return line

Some Gen 5 DD13 turbocharger oil return lines crack, causing an oil leak. Engineering is requesting additional steps to repair the lines and the return of replaced parts to help understand the root cause of these failures. If repaired, please return the parts directly to Detroit Diesel. This process is only to be performed until April 1, 2025, and only when the customer approves of the additional repair time that may occur.

Please return the cracked return line, the turbo mounting bracket, support bracket, and all associated bolts. See instructions below
