**Problem Details:**

**Affected Models / Truck options:**

- Affected vehicles M2+, 108SD and 114SD
- Population of affected vehicles 73,277 trucks

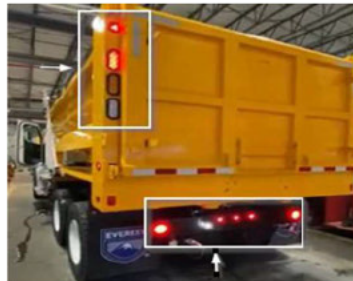
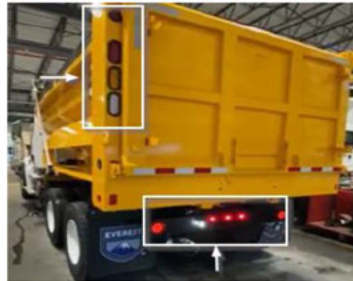
- The bodybuilder marker lamps are not synchronized with the truck
- After 10 seconds the marker lights will go off while the truck lights stay on
- XMC was set to power off for a battery preservation strategy

Parameter	Migration Plausibility		PID Speed Control		PTOT Engage B/MPTO
	Compare Configuration	Compare Parameters	Compare Server Data	Value	
XMC202T Extension Module Cabin 2					
PFS_C_Parameters_OutputPinBlock1_T2					
PFS_C_output_pin0004_stay_awake					
PFS_C_output_pin0005_PPISL					
PFS_C_output_pin0005_optr					
PFS_C_output_pin0006_PPISL					
PFS_C_output_pin0006_optr					
PFS_C_output_pin0006_stay_awake					
PFS_C_output_pin0007_PPISL

0 ECU\_SLEEP\_ALLOWED  
1 ECU\_SLEEP\_AWAKE

- XMC was going to sleep to preserve the battery

- 035 447 06 46 XMC Parameter to keep ECU Awake

- Service Solution 3158
