**Field Service Campaign**

SF703 A

**Subject: Cummins Engine with Wired Regen Inhibit Switch**

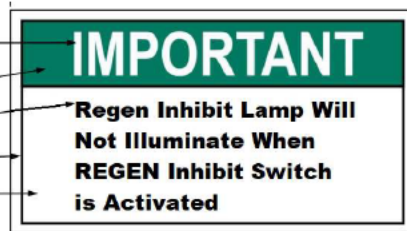
- M2 Plus with Cummins engines and Wired Regen Inhibit Switch (28F-015)
- Regen Inhibit lamp is not visible in ICUC (dash label indicates missing indicator)
- Switch functions *but* driver is unaware

- Software bug in CGW
- Message routing from SAM to cluster was missed

- New CGW software – same part number, ZGS 008 revision level
- Changed over 5/6/2024
