# Gen 5 DD13 Turbo Oil Drain Tubes Cracking

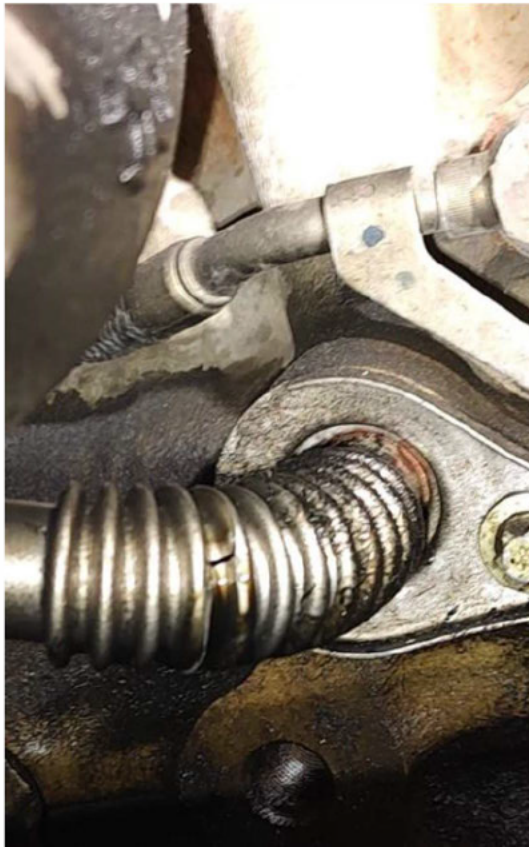
- Gen 5 DD13 turbo oil drain tubes are cracking and causing oil leaks. Based on returned material, missing turbo support bracket bolts appear to be a large contributing factor.

- Replace the turbo oil drain tube. Check the turbo mounting brackets for cracks or loose/missing bolts. Follow 24CSA-17.
