## SERVICE BULLETIN

APPLICABILITY: 2019-22MY Forester

**NUMBER:** 12-257-25R

SUBJECT: Windshield Warranty Extension / Inspection

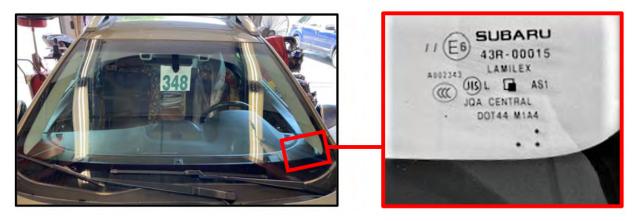
**STEP 1:** Locate the Subaru marking on the lower portion of the driver side of the glass. Confirm the windshield is a genuine Subaru part. If the marking cannot be found and / or the vehicle has been fitted with a non-Subaru windshield, the Warranty Extension does not apply.

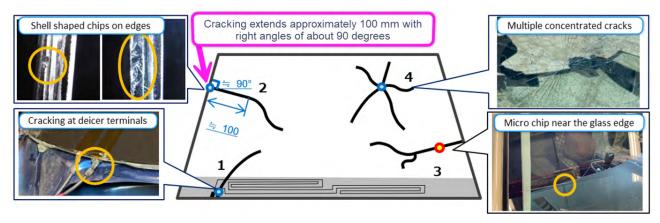
**STEP 2:** Inspect the damaged area(s) of the windshield and determine what type of damage is present. See the example images below for Warranty qualifying and non-qualifying windshield damage criteria. This damage described in Type 2 and 3 is not specific to one side of the glass and may occur in the upper or lower sections.

Туре	Descriptions	Presumed Cause	sumed Cause 3/36 Coverage	
1	The straight section extends to the edge of the glass with cracking starting from the deicer terminal.	Unrelated cause	COVERED	NOT COVERED
2	The straight section extends to the edge of the glass with the chip(s) along edge of the glass.	Unrelated cause	COVERED	NOT COVERED
3	A chip can be found within the straight section of a crack.	Cracking is presumed to have been caused by continuous stress starting from a small chip.  Refer to <b>APPENDIX A</b> for details	COVERED	COVERED
4	Multiple cracks are concentrated at one center point of a damage area. (spider web or star pattern)	External factors are presumed. Refer to <b>APPENDIX B</b> for details.	NOT COVERED	NOT COVERED

**STEP 3:** Is the windshield damage covered by the Warranty Extension (Type 3)?

**YES:** Replace the windshield as per the applicable Service Manual and process the claim using the Warranty Extension claim information supplied in this bulletin. Refer to STIS: Body & Electrical/WIRING SYSTEM.

**NO:** Consult with customer regarding replacement/repair options.
