## SERVICE BULLETIN

**APPLICABILITY:** 2018-24MY Ascent  
2019-24MY Outback & Legacy

**NUMBER:** 09-130-25

**SUBJECT:** Exhaust Manifold Flange Nut / Torque & Design Change

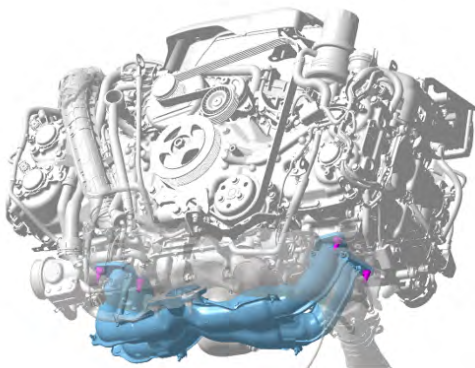
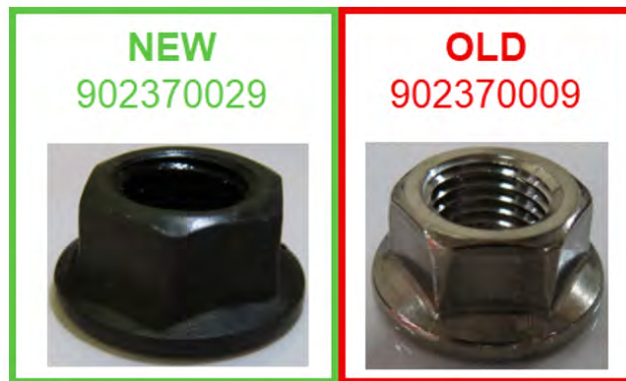
This bulletin announces the design change made to the exhaust manifold flange nuts. The material has been changed from a medium carbon steel to stainless steel. This change also necessitates a revised tightening torque specification. When replacement of the flange nuts is required, follow the part and service procedure information outlined in this bulletin.

**NOTE:** The new and old flange nuts should not be interchanged and always replaced as a set.
